Access Compliance Report

Public Rights-of-Way

(Curb Ramps)

Intersection ID: 50342	Main Street: HERMISTON_ST	Cross Street: STIRLINGSHIRE_CT	Location: NW
ADA ID: 04EA3CA2362A	Ramp Type: PerpDiag	Initial Pass/Fail: Fail	Overall Compliance: No
Severity Score: 25			
Codes/Mitigation Info/Possible Solution		Field Measurements/Component Compliance

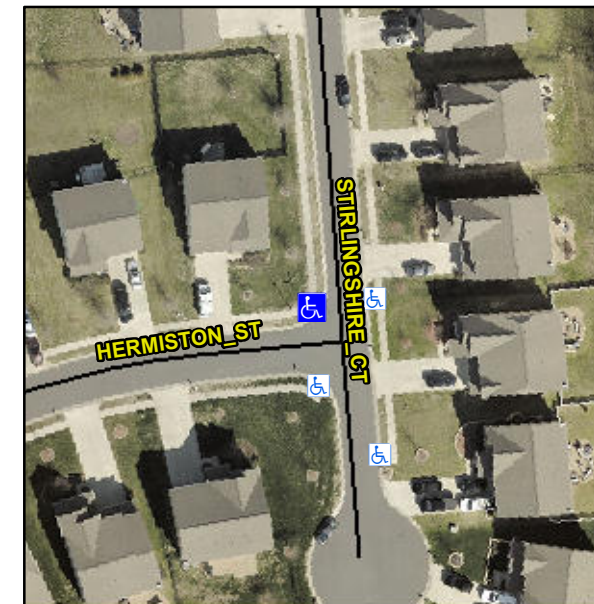
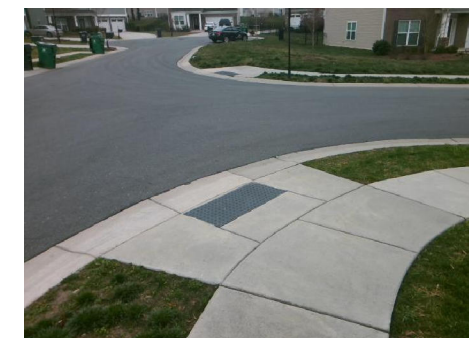
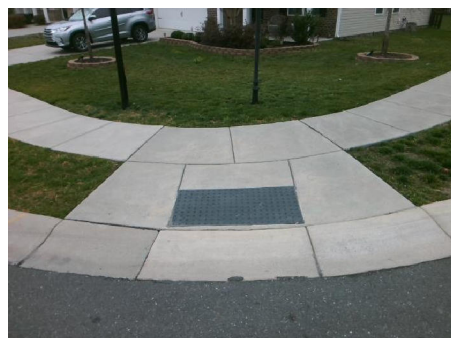
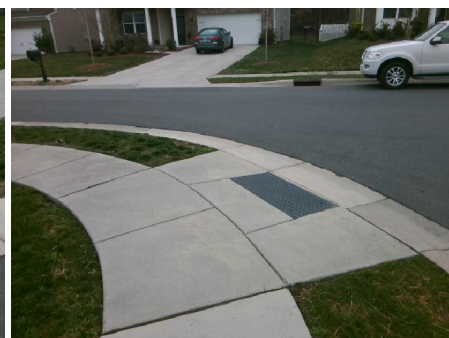
Compliance	Description	Data	Compliance	Description	Data
N/A	Ramp Length (in)	48.0	No	Ramp Slope (%)	9.2
Yes	Ramp Width (in)	48.0	No	Ramp XSlope (%)	6.4
N/A	Flare Type LT	N/A	N/A	Flare Type RT	N/A
N/A	Flare Slope LT (%)	N/A	N/A	Flare Slope RT (%)	N/A
N/A	Flare Traversable LT?	N/A	N/A	Flare Traversable RT?	N/A
N/A	Landing Length (in)	N/A	N/A	DWS Provided?	N/A
N/A	Landing Width (in)	N/A	N/A	DWS Contrast?	N/A
N/A	Landing Slope (%)	N/A	N/A	DWS Length (in)	N/A
N/A	Landing X Slope (%)	N/A	N/A	DWS Full Width?	N/A
N/A	Landing Curb? (Y/N)	N/A	N/A	DWS Offset (in)	N/A
N/A	Shared Landing?	N/A			
N/A	Gutter Ponding?	N/A	N/A	Gutter Slope (%)	N/A
N/A	Gutter Lip Ht (in)	N/A	N/A	Gutter X Slope (%)	N/A
N/A	Painted X Walk1?	No	N/A	Painted X Walk2?	No
	X Walk 1 Direction	To S		X Walk 2 Direction	To E
N/A	X Walk 1 Width (in)	N/A	N/A	X Walk 2 Width (in)	N/A
	X Walk 1 Slope (%)	3.2		X Walk 2 Slope (%)	4.7
	X Walk 1 X Slope (%)	4.9		X Walk 2 X Slope (%)	0.8

N/A	Ramp inside XWalk1?	N/A	N/A	Ramp inside XWalk2?	N/A
	Road Slope (%)	2.5	N/A	Clear Space?	N/A
	Road X Slope (%)	5.0	N/A	Clear Space to XWalk (in)	N/A
N/A	Any Obstructions?	N/A	N/A	Storm Grate/Utility Hazard?	N/A
	Obstruction Type			Storm Grate/Utility Type	
		N/A			N/A
			Yes	Surface Condition? (G/P)	Good

Remove & Replace Curb Ramp With Two New Directional Ramps or Equivalent.
