Access Compliance Report

Public Rights-of-Way

(Curb Ramps)

Intersection ID: 15031	Main Street: OPTIMIST_LN	Cross Street: WESTCHESTER_BV	Location: E
ADA ID: 04F22207C868	Ramp Type: Directional1	Initial Pass/Fail: Fail	Overall Compliance: No
Severity Score: 13.75			
Codes/Mitigation Info/Possible Solution		Field Measurements/Component Compliance

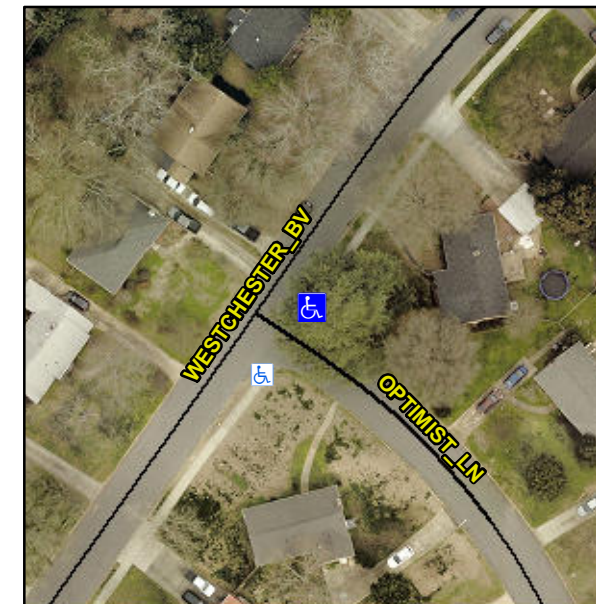
R304.2.2, R304.5.3

Compliance	Description	Data	Compliance	Description	Data
N/A	Ramp Length (in)	74.0	N/A	Grade Break?	N/A
Yes	Ramp Width (in)	59.0	N/A	Grade Break Slope (%)	0.0
No	Ramp Slope (%)	9.1	N/A	Grade Break XSlope (%)	0.0
No	Ramp XSlope (%)	3.5			
N/A	Flare Type LT	N/A	N/A	Flare Type RT	N/A
N/A	Flare Slope LT (%)	N/A	N/A	Flare Slope RT (%)	0.0
N/A	Flare Traversable LT?	N/A	N/A	Flare Traversable RT?	N/A
N/A	Landing Length (in)	0.0	N/A	DWS Provided?	N/A
N/A	Landing Width (in)	0.0	N/A	DWS Contrast?	N/A
N/A	Landing Slope (%)	0.0	N/A	DWS Length (in)	N/A
N/A	Landing X Slope (%)	0.0	N/A	DWS Full Width?	N/A
N/A	Landing Curb? (Y/N)	N/A	N/A	DWS Offset LT (in)	N/A
N/A	Shared Landing?	N/A	N/A	DWS Offset RT (in)	N/A
N/A	Gutter Ponding?	0.0	N/A	Gutter Slope (%)	N/A
N/A	Gutter Lip Ht (in)	0.5	N/A	Gutter X Slope (%)	N/A
N/A	Painted X Walk1?	No		Road Slope (%)	4.1
	X Walk 1 Direction	To SW		Road X Slope (%)	4.6
	X Walk 1 Width (in)	N/A		Clear Space?	N/A

X Walk 1 Slope (%)	4.1	N/A	Clear Space to XWalk (in)	N/A
	X Walk 1 X Slope (%)	4.6	N/A	Storm Grate/Utility Hazard?	N/A
N/A	Ramp inside XWalk1?	N/A		Storm Grate/Utility Type	
N/A	Any Obstructions?	N/A			N/A
	Obstruction Type		Yes	Surface Condition? (G/P)	Good
			N/A	Curb Slope (%)	11.2

Remove & Replace Entire Ramp.
