# Access Compliance Report

## Public Rights-of-Way

### (Curb Ramps)

| Intersection ID: 48867 | Main Street: ERWIN_RD | Cross Street: LION_CUB_LN | Location: SW |

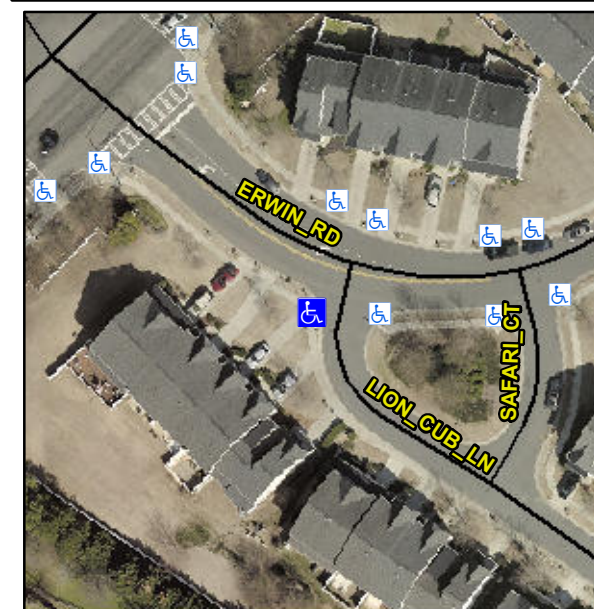
**R304.2.2, R304.5.3**

| Compliance | Description | Data | Compliance | Description | Data |
|---|---|---|---|---|---|
| N/A | Ramp Length (in) | 28.0 | No | Ramp Slope (%) | 14.5 |
| Yes | Ramp Width (in) | 48.0 | No | Ramp XSlope (%) | 5.3 |

**Remove & Replace Curb Ramp With Two New Directional Ramps or Equivalent.**

Total Cost: \$ 3200.00
