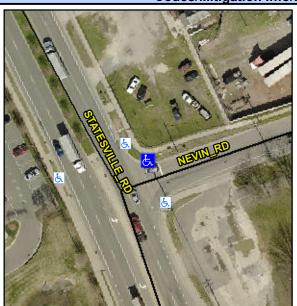
Intersection ID: 6998 Main Street: NEVIN_RD Cross Street: STATESVILLE_RD Location: NE **Overall Compliance: No** ADA ID: 050C1F419B5C Ramp Type: Perp Initial Pass/Fail: Fail **Severity Score:** 8.75

Field Measurements/Component Compliance							
Comp	liance Description	Data	Comp	liance Description	Data		
N/A	Ramp Length (in)	96.5	Yes	Ramp Slope (%)	7.7		
No	Ramp Width (in)	47.0	Yes	Ramp XSlope (%)	0.8		
N/A	Flare Type LT	N/A	N/A	Flare Type RT	N/A		
N/A	Flare Slope LT (%)	N/A	N/A	Flare Slope RT (%)	N/A		
N/A	Flare Traversable LT?	N/A	N/A	Flare Traversable RT?	N/A		
N/A	Landing Length (in)	N/A	N/A	DWS Provided?	N/A		
N/A	Landing Width (in)	N/A	N/A	DWS Contrast?	N/A		
N/A	Landing Slope (%)	N/A	N/A	DWS Length (in)	N/A		
N/A	Landing X Slope (%)	N/A	N/A	DWS Full Width?	N/A		
N/A	Landing Curb? (Y/N)	N/A	N/A	DWS Offset (in)	N/A		
N/A	Shared Landing?	N/A					
N/A	Gutter Ponding?	N/A	N/A	Gutter Slope (%)	N/A		
N/A	Gutter Lip Ht (in)	N/A	N/A	Gutter X Slope (%)	N/A		
N/A	Painted X Walk1?	No	N/A	Painted X Walk2?	N/A		
	X Walk 1 Direction	To S		X Walk 2 Direction	N/A		
N/A	X Walk 1 Width (in)	N/A	N/A	X Walk 2 Width (in)	N/A

occibio Colditoli		
ossible Solutions:	Cor	
Remove & Replace Entire Ramp.		
·	No	
	N/A	
surveyor Notes:	N/A	
N/A	N/A	
	N/A	
	N/A	
	N/A	
ROW/ADA:	N/A	
Not Found, R304.5.1	N/A

Total Cost: 1850.00
