Access Compliance Report Public Rights-of-Way (Curb Ramps)

Intersection ID: 4496 Main Street: HIGH GLEN DR					Straat		Location:	NE			
		Main Street: HIGH_GLEN_DR			Cross Street: NORCROFT_DR						
ADA ID: 051076B2DB77	DA ID: 051076B2DB77 Ramp Type: Perp			Initial F	Initial Pass/Fail: Fail Overall Compliance: No				o Severity Score:	46.25	
Codes/Mitigation Info/Possible Solution					Field Measurements/Component Compliance						
	6 5	Possible Solutions:			Compliance Description			Data Compliance Description			
	1000	Remove & Replace E	Entire Ramp).	N/A	Ramp Length (in)	122.0	No	Ramp Slope (%)	11.6	
RIDEL			-		No	Ramp Width (in)	41.0	No	Ramp XSlope (%)	7.5	
E Contraction of the second se					N/A	Flare Type LT	N/A	N/A	Flare Type RT	N/A	
	The a los				N/A	Flare Slope LT (%)	N/A	N/A	Flare Slope RT (%)	N/A	
5	a martine				N/A	Flare Traversable LT?	N/A	N/A	Flare Traversable RT?	N/A	
12 ····································					N/A	Landing Length (in)	N/A	N/A	DWS Provided?	N/A

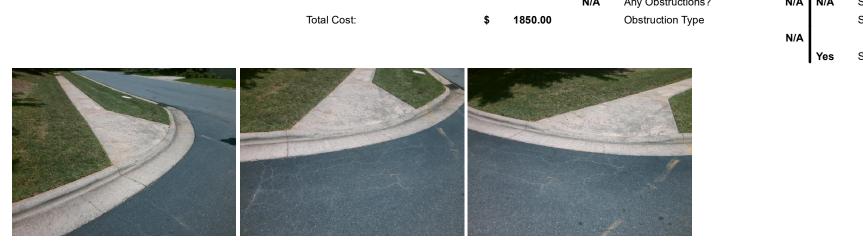
and the second s	a hard a second	Surveyor Notes:			N/A	Landing Width (in)	N/A	N/A	DWS Contrast?	N/A	
the second secon	The second	N/A			N/A	Landing Slope (%)	N/A	N/A	DWS Length (in)	N/A	
NOROROFT_DR	- CARLES - CARLES				N/A	Landing X Slope (%)	N/A	N/A	DWS Full Width?	N/A	
					N/A	Landing Curb? (Y/N)	N/A	N/A	DWS Offset (in)	N/A	
1	a B				N/A	Shared Landing?	N/A				
and the second sec	and a fail to	PROW/ADA:			N/A	Gutter Ponding?	N/A	N/A	Gutter Slope (%)	N/A	
	Not Found, R304.5.1	I. R304.2.2.		N/A	Gutter Lip Ht (in)	N/A	N/A	Gutter X Slope (%)	N/A		
		R304.5.3	, ,		N/A	Painted X Walk1?	No	N/A	Painted X Walk2?	N/A	
PROW/ADA: Not Found, R304.5.1, R304.2.2, R304.5.3					X Walk 1 Direction	To NW		X Walk 2 Direction	N/A		
				N/A	X Walk 1 Width (in)	N/A	N/A	X Walk 2 Width (in)	N/A		
Street 1 Name	HIGH GLEN DR					X Walk 1 Slope (%)	1.7		X Walk 2 Slope (%)	N/A	
Stop Condition-Street 2	StopSign					X Walk 1 X Slope (%)	6.2		X Walk 2 X Slope (%)	N/A

Street 2 Name	N/A				N/A	Ramp inside XWalk1?	N/A	N/A	Ramp inside XWalk2?	N/A	
Stop Condition-Street 1	N/A					Road Slope (%)	N/A	N/A	Clear Space?	N/A	
						Road X Slope (%)	N/A	N/A	Clear Space to XWalk (in)	N/A	
					N/A	Any Obstructions?	N/A	N/A	Storm Grate/Utility Hazard?	N/A	
		Total Cost:	\$	1850.00		Obstruction Type			Storm Grate/Utility Type		
							N/A			N/A
