Access Compliance Report

Public Rights-of-Way

(Curb Ramps)

Intersection ID: 10031842	Main Street: MINTWORTH_AV	Cross Street: N/A	Location: NE
ADA ID: 0522193B4C4B	Ramp Type: Perp	Initial Pass/Fail: Fail	Overall Compliance: No
Severity Score: 25			
Codes/Mitigation Info/Possible Solution		Field Measurements/Component Compliance

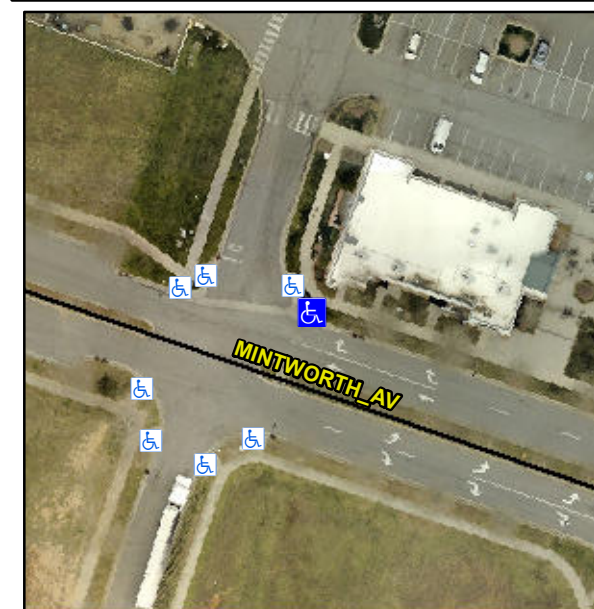
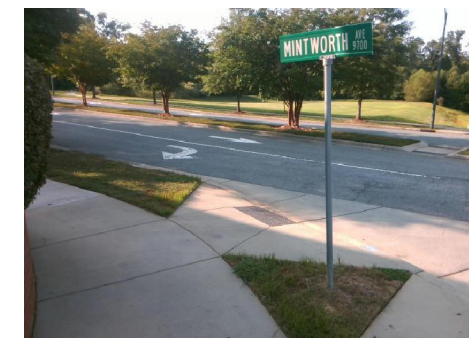
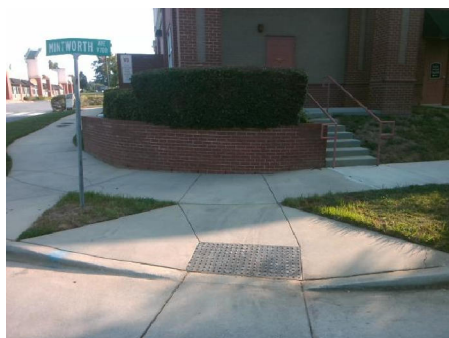
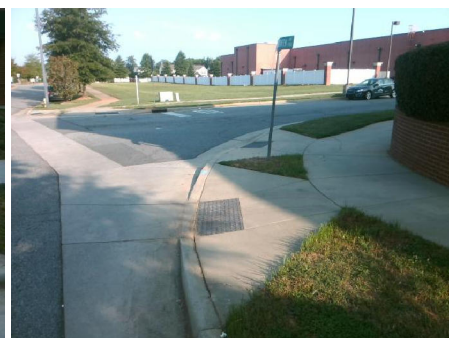
Compliance	Description	Data	Compliance	Description	Data
N/A	Ramp Length (in)	75.0	No	Ramp Slope (%)	12.0
Yes	Ramp Width (in)	48.0	Yes	Ramp XSlope (%)	1.3
N/A	Flare Type LT	N/A	N/A	Flare Type RT	N/A
N/A	Flare Slope LT (%)	N/A	N/A	Flare Slope RT (%)	N/A
N/A	Flare Traversable LT?	N/A	N/A	Flare Traversable RT?	N/A
N/A	Landing Length (in)	N/A	N/A	DWS Provided?	N/A
N/A	Landing Width (in)	N/A	N/A	DWS Contrast?	N/A
N/A	Landing Slope (%)	N/A	N/A	DWS Length (in)	N/A
N/A	Landing X Slope (%)	N/A	N/A	DWS Full Width?	N/A
N/A	Landing Curb? (Y/N)	N/A	N/A	DWS Offset (in)	N/A
N/A	Shared Landing?	N/A			
N/A	Gutter Ponding?	N/A	N/A	Gutter Slope (%)	N/A
N/A	Gutter Lip Ht (in)	N/A	N/A	Gutter X Slope (%)	N/A
N/A	Painted X Walk1?	No	N/A	Painted X Walk2?	N/A
	X Walk 1 Direction	To SW		X Walk 2 Direction	N/A
N/A	X Walk 1 Width (in)	N/A	N/A	X Walk 2 Width (in)	N/A
	X Walk 1 Slope (%)	1.6		X Walk 2 Slope (%)	N/A
	X Walk 1 X Slope (%)	0.5		X Walk 2 X Slope (%)	N/A

N/A	Ramp inside XWalk1?	N/A	N/A	Ramp inside XWalk2?	N/A
	Road Slope (%)	N/A	N/A	Clear Space?	N/A
	Road X Slope (%)	N/A	N/A	Clear Space to XWalk (in)	N/A
N/A	Any Obstructions?	N/A	N/A	Storm Grate/Utility Hazard?	N/A
	Obstruction Type			Storm Grate/Utility Type	
		N/A			N/A
			Yes	Surface Condition? (G/P)	Good

Remove & Replace Entire Ramp.

R304.2.2

\$ 1850.00
