# Access Compliance Report

## Public Rights-of-Way

### (Curb Ramps)

Intersection ID: 10040	Main Street: HAZEL_ST	Cross Street: TUCKASEEGEE_RD	Location: SE
ADA ID: 052A1EBF7BD3	Ramp Type: Directional1	Initial Pass/Fail: Fail	Overall Compliance: No
Severity Score: 8.75			
Codes/Mitigation Info/Possible Solution		Field Measurements/Component Compliance

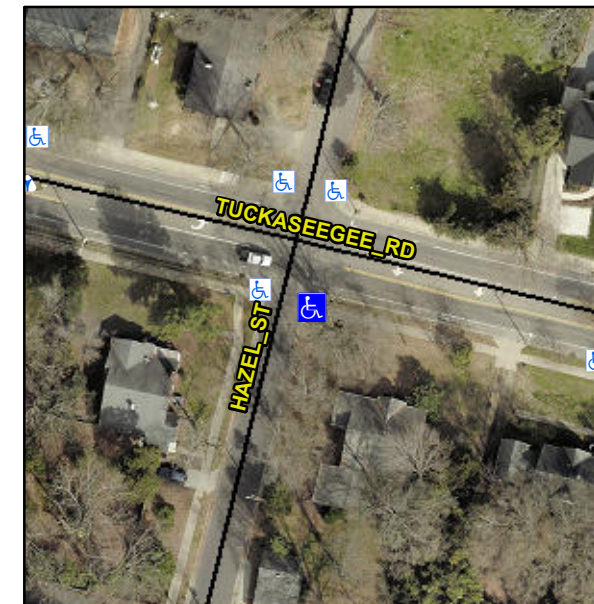
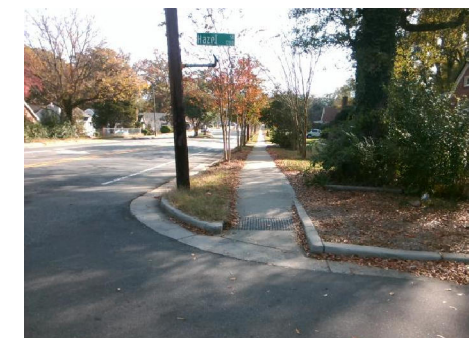
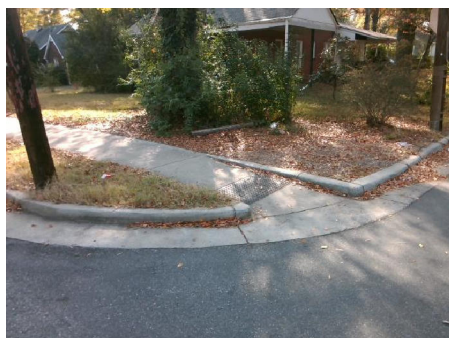
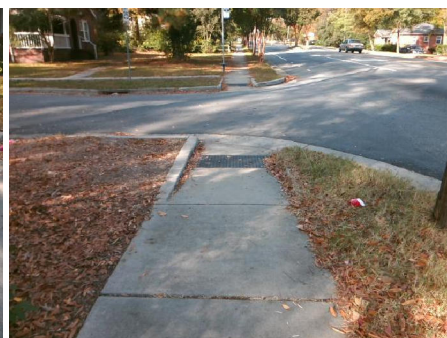
Compliance	Description	Data	Compliance	Description	Data
N/A	Ramp Length (in)	90.0	N/A	Grade Break?	N/A
No	Ramp Width (in)	47.5	N/A	Grade Break Slope (%)	0.0
Yes	Ramp Slope (%)	7.5	N/A	Grade Break XSlope (%)	0.0
Yes	Ramp XSlope (%)	1.2			
N/A	Flare Type LT	N/A	N/A	Flare Type RT	N/A
N/A	Flare Slope LT (%)	N/A	N/A	Flare Slope RT (%)	0.0
N/A	Flare Traversable LT?	N/A	N/A	Flare Traversable RT?	N/A
N/A	Landing Length (in)	0.0	N/A	DWS Provided?	N/A
N/A	Landing Width (in)	0.0	N/A	DWS Contrast?	N/A
N/A	Landing Slope (%)	0.0	N/A	DWS Length (in)	N/A
N/A	Landing X Slope (%)	0.0	N/A	DWS Full Width?	N/A
N/A	Landing Curb? (Y/N)	N/A	N/A	DWS Offset LT (in)	N/A
N/A	Shared Landing?	N/A	N/A	DWS Offset RT (in)	N/A
N/A	Gutter Ponding?	0.0	N/A	Gutter Slope (%)	N/A
N/A	Gutter Lip Ht (in)	0.0	N/A	Gutter X Slope (%)	N/A
N/A	Painted X Walk1?	No		Road Slope (%)	3.0
	X Walk 1 Direction	To W		Road X Slope (%)	2.7
	X Walk 1 Width (in)	N/A		Clear Space?	N/A

X Walk 1 Slope (%)	3.0	N/A	Clear Space to XWalk (in)	N/A
	X Walk 1 X Slope (%)	2.7	N/A	Storm Grate/Utility Hazard?	N/A
N/A	Ramp inside XWalk1?	N/A		Storm Grate/Utility Type	
N/A	Any Obstructions?	N/A			N/A
	Obstruction Type		Yes	Surface Condition? (G/P)	Good
			N/A	Curb Slope (%)	0.6

**Remove & Replace Entire Ramp.**

**R304.5.1**

**\$ 1600.00**
