Access Compliance Report

Public Rights-of-Way

(Curb Ramps)

Intersection ID: 27456	Main Street: BALLANTYNE_MEADOWS_DR	Cross Street: GRAHAMWOOD_PL	Location: NE
ADA ID: 052C79D8A942	Ramp Type: Perp	Initial Pass/Fail: Fail	Overall Compliance: No
Severity Score: 13.75			
Codes/Mitigation Info/Possible Solution		Field Measurements/Component Compliance

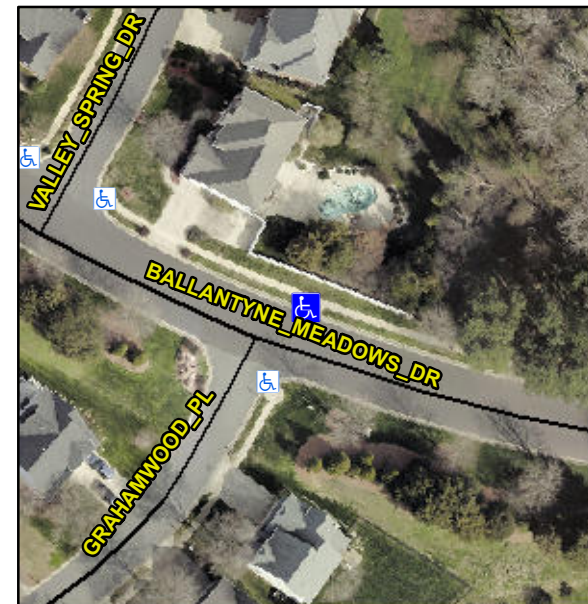
R304.2.2, R304.5.3

Compliance	Description	Data	Compliance	Description	Data
N/A	Ramp Length (in)	48.0	No	Ramp Slope (%)	10.8
Yes	Ramp Width (in)	48.0	No	Ramp XSlope (%)	3.5
N/A	Flare Type LT	N/A	N/A	Flare Type RT	N/A
N/A	Flare Slope LT (%)	N/A	N/A	Flare Slope RT (%)	N/A
N/A	Flare Traversable LT?	N/A	N/A	Flare Traversable RT?	N/A
N/A	Landing Length (in)	N/A	N/A	DWS Provided?	N/A
N/A	Landing Width (in)	N/A	N/A	DWS Contrast?	N/A
N/A	Landing Slope (%)	N/A	N/A	DWS Length (in)	N/A
N/A	Landing X Slope (%)	N/A	N/A	DWS Full Width?	N/A
N/A	Landing Curb? (Y/N)	N/A	N/A	DWS Offset (in)	N/A
N/A	Shared Landing?	N/A			
N/A	Gutter Ponding?	N/A	N/A	Gutter Slope (%)	N/A
N/A	Gutter Lip Ht (in)	N/A	N/A	Gutter X Slope (%)	N/A
N/A	Painted X Walk1?	No	N/A	Painted X Walk2?	N/A
	X Walk 1 Direction	To SW		X Walk 2 Direction	N/A
N/A	X Walk 1 Width (in)	N/A	N/A	X Walk 2 Width (in)	N/A
	X Walk 1 Slope (%)	2.3		X Walk 2 Slope (%)	N/A
	X Walk 1 X Slope (%)	1.0		X Walk 2 X Slope (%)	N/A

N/A	Ramp inside XWalk1?	N/A	N/A	Ramp inside XWalk2?	N/A
	Road Slope (%)	N/A	N/A	Clear Space?	N/A
	Road X Slope (%)	N/A	N/A	Clear Space to XWalk (in)	N/A
N/A	Any Obstructions?	N/A	N/A	Storm Grate/Utility Hazard?	N/A
	Obstruction Type			Storm Grate/Utility Type	
		N/A			N/A
			Yes	Surface Condition? (G/P)	Good

Possible Solutions:

Remove & Replace Entire Ramp.
