Access Compliance Report Public Rights-of-Way (Curb Ramps)

Intersection ID: 30542 Main Street: AMBERWOOD_CT Cross Street: SUMMERHILL_RIDGE_DR Location: N

ADA ID: 055BF0ADEEDF Ramp Type: PerpDiag Initial Pass/Fail: Fail Overall Compliance: No Severity Score: 12.5

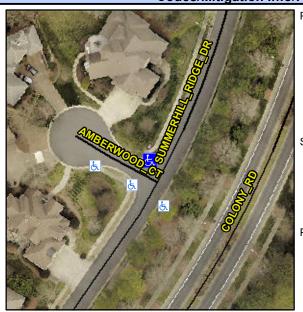
PROW/ADA:
Not Found, R304.5.3

| Field Measurements/Component Compliance | | | | | | |
|---|---|---|---|---|---|---|
| | Yes | Ramp Width (in) | 54.0 | No | Ramp XSlope (%) | 5.4 |

Remove & Replace Curb Ramp With
Two New Directional Ramps or
Equivalent.
