Access Compliance Report

Public Rights-of-Way

(Curb Ramps)

Intersection ID: 8588	Main Street: HYDE_DR	Cross Street: W_CRAIGHEAD_RD	Location: NW
ADA ID: 0574F6CDC177	Ramp Type: Combination2	Initial Pass/Fail: Fail	Overall Compliance: No
		Severity Score: 10

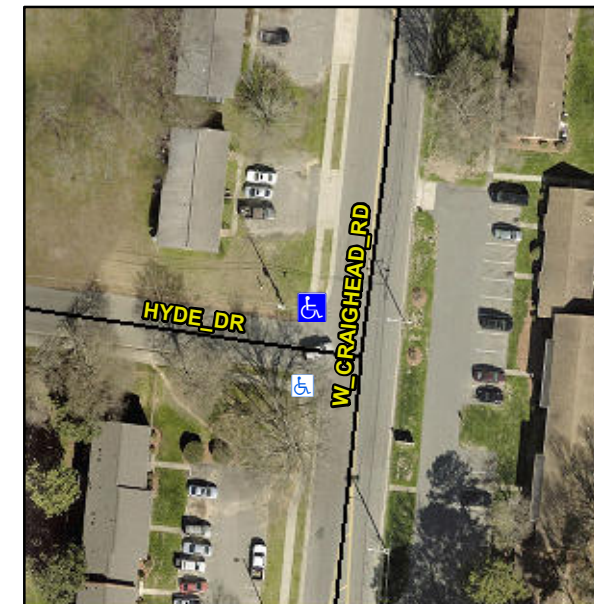
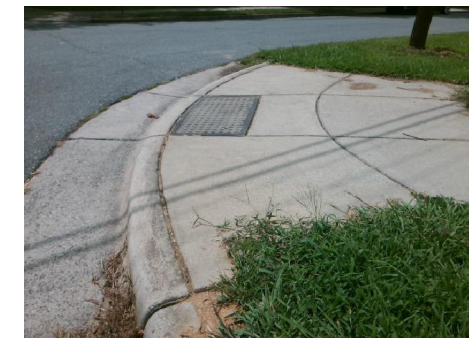
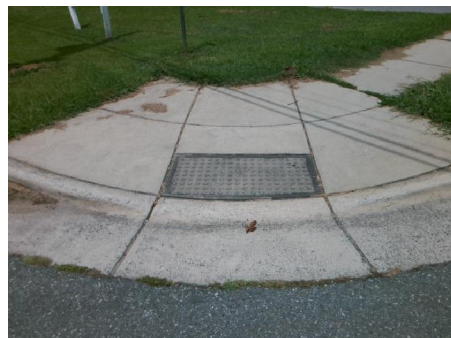
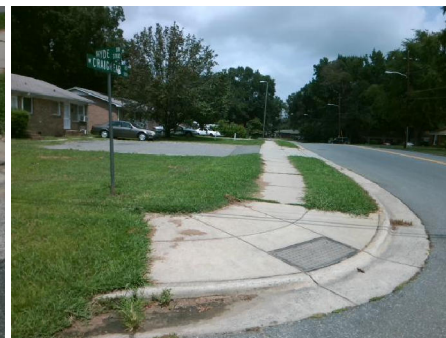
LT RP < 5%

Not Found, R304.5.1, R304.5.3

Compliance	Description	Data	Compliance	Description	Data
N/A	Ramp Length LT (in)	28.5	N/A	Ramp Length RT (in)	17.0
N/A	Ramp Width LT (in)	61.0	Yes	Ramp Width RT (in)	62.0
N/A	Ramp Slope LT (%)	2.2	Yes	Ramp Slope RT (%)	5.8
N/A	Ramp XSlope LT (%)	1.6	No	Ramp XSlope RT (%)	2.1
N/A	Ramp Length (in)	48.5	Yes	Ramp Slope (%)	7.8
No	Ramp Width (in)	47.5	No	Ramp XSlope (%)	3.5
N/A	Flare Type LT	N/A	N/A	Flare Type RT	N/A
N/A	Flare Slope LT (%)	N/A	N/A	Flare Slope RT (%)	N/A
N/A	Flare Traversable LT?	N/A	N/A	Flare Traversable RT?	N/A
N/A	Landing Length (in)	N/A	N/A	DWS Provided?	N/A
N/A	Landing Width (in)	N/A	N/A	DWS Contrast?	N/A
N/A	Landing Slope (%)	N/A	N/A	DWS Length (in)	N/A
N/A	Landing X Slope (%)	N/A	N/A	DWS Full Width?	N/A
N/A	Landing Curb? (Y/N)	N/A	N/A	DWS Offset (in)	N/A
N/A	Shared Landing?	N/A			
N/A	Gutter Ponding?	N/A	N/A	Gutter Slope (%)	N/A
N/A	Gutter Lip Ht (in)	N/A	N/A	Gutter X Slope (%)	N/A
N/A	Painted X Walk1?	No	N/A	Painted X Walk2?	N/A

X Walk 1 Direction	To S		X Walk 2 Direction	N/A
	X Walk 1 Width (in)	N/A		X Walk 2 Width (in)	N/A
	X Walk 1 Slope (%)	2.6		X Walk 2 Slope (%)	N/A
	X Walk 1 X Slope (%)	3.2		X Walk 2 X Slope (%)	N/A
N/A	Ramp inside XWalk1?	N/A	N/A	Ramp inside XWalk2?	N/A
	Road Slope (%)	N/A		Clear Space?	N/A
	Road X Slope (%)	N/A	N/A	Clear Space to XWalk (in)	N/A
			N/A	Any Obstruction?	N/A
				Obstruction Type	N/A
			N/A	Storm Grate/Utility Hazard?	N/A
				Storm Grate/Utility Type	N/A
			Yes	Surface Condition? (G/P)	Good
				Curb Slope (%)	24.0

Possible Solutions:

Remove & Replace Entire Ramp.
