Access Compliance Report

Public Rights-of-Way

(Curb Ramps)

Intersection ID: 6475	Main Street: CAPPS_HILL_MINE_RD	Cross Street: FIRESTONE_DR	Location:	W
ADA ID: 059DFFE1C724	Ramp Type: Perp	Initial Pass/Fail: Fail	Overall Compliance: No	Severity Score: 10

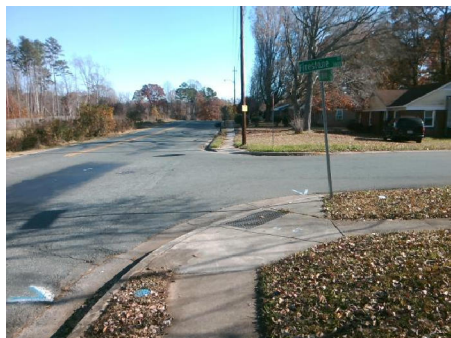
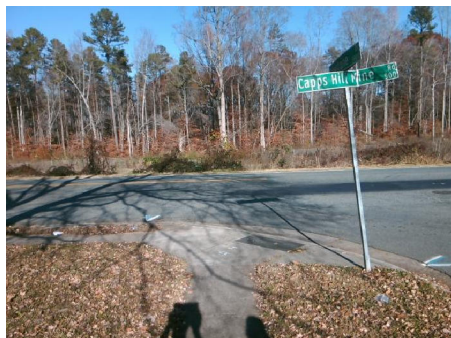
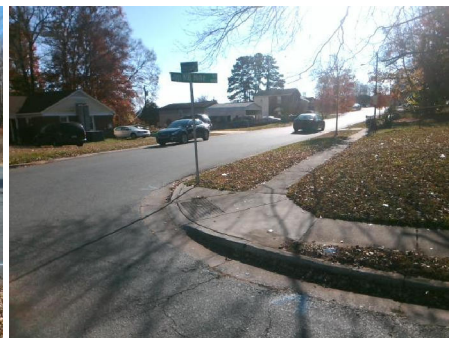
N/A	Shared Landing?	N/A			
		N/A	Gutter Ponding?	N/A	N/A	Gutter Slope (%)	N/A
		N/A	Gutter Lip Ht (in)	0.5	N/A	Gutter X Slope (%)	N/A
		N/A	Painted X Walk1?	No	N/A	Painted X Walk2?	N/A
			X Walk 1 Direction	To SE		X Walk 2 Direction	N/A
		N/A	X Walk 1 Width (in)	N/A	N/A	X Walk 2 Width (in)	N/A
			X Walk 1 Slope (%)	2.2		X Walk 2 Slope (%)	N/A
			X Walk 1 X Slope (%)	0.8		X Walk 2 X Slope (%)	N/A
		N/A	Ramp inside XWalk1?	N/A	N/A	Ramp inside XWalk2?	N/A
			Road Slope (%)	N/A	N/A	Clear Space?	N/A
			Road X Slope (%)	N/A	N/A	Clear Space to XWalk (in)	N/A
		N/A	Any Obstructions?	N/A	N/A	Storm Grate/Utility Hazard?	N/A
			Obstruction Type			Storm Grate/Utility Type	
				N/A			N/A
					Yes	Surface Condition? (G/P)	Good

Possible Solutions:	Remove & Replace Entire Ramp.					
	Surveyor Notes:	N/A					
	PROW/ADA:	Not Found, R304.5.1, R304.5.3					
	Street 1 Name	FIRESTONE DR					
	Stop Condition-Street 2	StopSign					
	Street 2 Name	N/A					
	Stop Condition-Street 1	N/A					
	Total Cost:	\$ 1850.00					
		Compliance	Description	Data	Compliance	Description	Data
		N/A	Ramp Length (in)	60.0	Yes	Ramp Slope (%)	5.9
		No	Ramp Width (in)	47.5	No	Ramp XSlope (%)	3.7
		N/A	Flare Type LT	N/A	N/A	Flare Type RT	N/A
		N/A	Flare Slope LT (%)	N/A	N/A	Flare Slope RT (%)	N/A
		N/A	Flare Traversable LT?	N/A	N/A	Flare Traversable RT?	N/A
		N/A	Landing Length (in)	N/A	N/A	DWS Provided?	N/A
		N/A	Landing Width (in)	N/A	N/A	DWS Contrast?	N/A
		N/A	Landing Slope (%)	N/A	N/A	DWS Length (in)	N/A
		N/A	Landing X Slope (%)	N/A	N/A	DWS Full Width?	N/A
		N/A	Landing Curb? (Y/N)	N/A	N/A	DWS Offset (in)	N/A
