# Access Compliance Report

## Public Rights-of-Way

### (Curb Ramps)

Intersection ID: 22470	Main Street: SHARON_VIEW_RD	Cross Street: BENTRIDGE_DR	Location: SW
ADA ID: 059E9F3AE764	Ramp Type: PerpDiag	Initial Pass/Fail: Fail	Overall Compliance: No
		Severity Score: 37.5

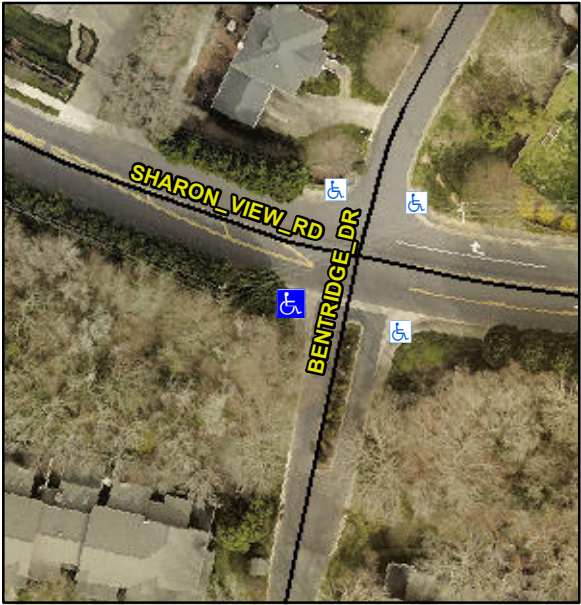
Possible Solutions:		<b>Compliance</b>	<b>Description</b>	<b>Data</b>
	<b>Remove &amp; Replace Curb Ramp With Two New Directional Ramps or Equivalent.</b>		<b>No</b>	Ramp Length (in)	<b>61.0</b>
			<b>Yes</b>	Ramp Width (in)	<b>48.0</b>
			<b>N/A</b>	Flare Type LT	<b>N/A</b>
			<b>N/A</b>	Flare Slope LT (%)	<b>N/A</b>
			<b>N/A</b>	Flare Traversable LT?	<b>N/A</b>
			<b>N/A</b>	Landing Length (in)	<b>N/A</b>
			<b>N/A</b>	Landing Width (in)	<b>N/A</b>
			<b>N/A</b>	Landing Slope (%)	<b>N/A</b>
			<b>N/A</b>	Landing X Slope (%)	<b>N/A</b>
<p>Surveyor Notes:</p> <p><b>N/A</b></p> <p>PROW/ADA:</p> <p><b>Not Found, R304.2.2, R304.5.3</b></p>			<b>N/A</b>	Flare Type RT	<b>N/A</b>
			<b>N/A</b>	Flare Slope RT (%)	<b>N/A</b>
			<b>N/A</b>	Flare Traversable RT?	<b>N/A</b>
			<b>N/A</b>	DWS Provided?	<b>N/A</b>
			<b>N/A</b>	DWS Contrast?	<b>N/A</b>
