Access Compliance Report Public Rights-of-Way (Curb Ramps)

Intersection ID: 49294 Main Street: ELIZABETH_CREST_LN Cross Street: CREEKSIDE_PARK_RD Location: SE

ADA ID: 05A72AA18BE3 Ramp Type: Perp Initial Pass/Fail: Fail Overall Compliance: No Severity Score: 12.5

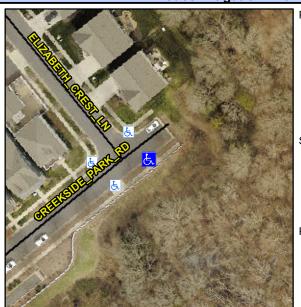
Field Measurements/Component Compliance								
Compliance Description		Data	Compl	iance Description	Data			
N/A	Ramp Length (in)	72.0	No	Ramp Slope (%)	8.7			
Yes	Ramp Width (in)	48.0	Yes	Ramp XSlope (%)	1.3			
N/A	Flare Type LT	N/A	N/A	Flare Type RT	N/A			
N/A	Flare Slope LT (%)	N/A	N/A	Flare Slope RT (%)	N/A			
N/A	Flare Traversable LT?	N/A	N/A	Flare Traversable RT?	N/A			
N/A	Landing Length (in)	N/A	N/A	DWS Provided?	N/A			
N/A	Landing Width (in)	N/A	N/A	DWS Contrast?	N/A			
N/A	Landing Slope (%)	N/A	N/A	DWS Length (in)	N/A			
N/A	Landing X Slope (%)	N/A	N/A	DWS Full Width?	N/A			
N/A	Landing Curb? (Y/N)	N/A	N/A	DWS Offset (in)	N/A			
N/A	Shared Landing?	N/A						
N/A	Gutter Ponding?	N/A	N/A	Gutter Slope (%)	N/A			
N/A	Gutter Lip Ht (in)	N/A	N/A	Gutter X Slope (%)	N/A			
N/A	Painted X Walk1?	No	N/A	Painted X Walk2?	N/A			
	X Walk 1 Direction	To NW		X Walk 2 Direction	N/A			
N/A	X Walk 1 Width (in)	N/A	N/A	X Walk 2 Width (in)	N/A

X Walk 1 Slope (%)	4.1		X Walk 2 Slope (%)	N/A			
	X Walk 1 X Slope (%)	1.9		X Walk 2 X Slope (%)	N/A			
N/A	Ramp inside XWalk1?	N/A	N/A	Ramp inside XWalk2?	N/A			
	Road Slope (%)	N/A	N/A	Clear Space?	N/A			
	Road X Slope (%)	N/A	N/A	Clear Space to XWalk (in)	N/A			
N/A	Any Obstructions?	N/A	N/A	Storm Grate/Utility Hazard?	N/A			
	Obstruction Type			Storm Grate/Utility Type				
		N/A			N/A			
			Yes	Surface Condition? (G/P)	Good

<u> </u>	1 COSIDIC COIGNON	
Ô	Possible Solutions:	C
	Remove & Replace Entire Ramp.	N
		Ye
		N
		N.
		N
4		N.
	Surveyor Notes:	N
	N/A	N
į		N
ğ		N
ò		N
	PROW/ADA:	N
	Not Found, R304.2.2	N
h	·	N
1		
H		N
		N
