## **Access Compliance Report Public Rights-of-Way** (Curb Ramps)

Intersection ID: 18778 Main Street: E INDEPENDENCE BV Cross Street: E W T HARRIS BV Location: NE ADA ID: 05AC7B0CDB6C Ramp Type: PerpDiag Initial Pass/Fail: Fail **Overall Compliance: No** Severity Score: 13.75

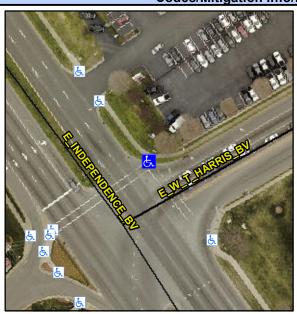
Field Measurements/Component Compliance  Compliance Description Data Compliance Description Data						
N/A	Ramp Length (in)	59.0	No		Slope (%)	8.9
Yes	Ramp Width (in)	48.0	No	•	XSlope (%)	4.2
N/A	Flare Type LT	N/A	N/A		Type RT	N/A
N/A	Flare Slope LT (%)	N/A	N/A		Slope RT (%)	N/A
N/A	Flare Traversable LT?	N/A	N/A		Traversable RT?	N/A
N/A	Landing Length (in)	N/A	N/A		Provided?	N/A
N/A	Landing Width (in)	N/A	N/A		Contrast?	N/A
N/A	Landing Slope (%)	N/A	N/A		Length (in)	N/A
N/A	Landing X Slope (%)	N/A	N/A		Full Width?	N/A
N/A	Landing Curb? (Y/N)	N/A	N/A		Offset (in)	N/A
N/A	Shared Landing?	N/A	10/4	DWG	Olisot (III)	147
N/A	Gutter Ponding?	N/A	N/A	Gutte	r Slope (%)	N/A
N/A	Gutter Lip Ht (in)	N/A	N/A		r X Slope (%)	N/A
N/A	Painted X Walk1?	Yes	N/A		ed X Walk2?	Yes
IV/A	X Walk 1 Direction	To W	IV/A		lk 2 Direction	To S
N/A	X Walk 1 Width (in)	86.0	N/A		lk 2 Width (in)	85.0
N/A	` '		IN/A		,	3.7
	X Walk 1 Slope (%)	2.9			lk 2 Slope (%)

NI/A	X Walk 1 X Slope (%)	2.2	NI/A		lk 2 X Slope (%)	2.1
N/A	Ramp inside XWalk1?	Yes	N/A	•	inside XWalk2?	Yes
	Road Slope (%)	3.0	N/A		Space?	N/A
	Road X Slope (%)	0.0	N/A		Space to XWalk (in)	N/A
N/A	Any Obstructions?	N/A	N/A		Grate/Utility Hazard?	N/A
	Obstruction Type			Storm	Grate/Utility Type	
		N/A				N/A
			Yes	Surfac	ce Condition? (G/P)	Good

Possible Solutions:	Complia	
Remove & Replace Curb Ramp With	N/A	F
Two New Directional Ramps or	Yes	F
Equivalent.	N/A	
	N/A	
	N/A	
	N/A	ı
Surveyor Notes:	N/A	I
N/A	N/A	ı
	N/A	ı
	N/A	I
	N/A	;
PROW/ADA:	N/A	
Not Found, R304.2.2, R304.5.3	N/A	(
	N/A	ı
		2
	N/A	2
		2
		2
	N/A	ı
		ı
		ı
