# Access Compliance Report

## Public Rights-of-Way

### (Curb Ramps)

Intersection ID: 6144	Main Street: BACK_CREEK_CHURCH_RD	Cross Street: COREOPSIS_RD	Location: SE
ADA ID: 05BF02E798E9	Ramp Type: Perp	Initial Pass/Fail: Fail	Overall Compliance: No
Codes/Mitigation Info/Possible Solution		Field Measurements/Component Compliance	
Severity Score: 13.75

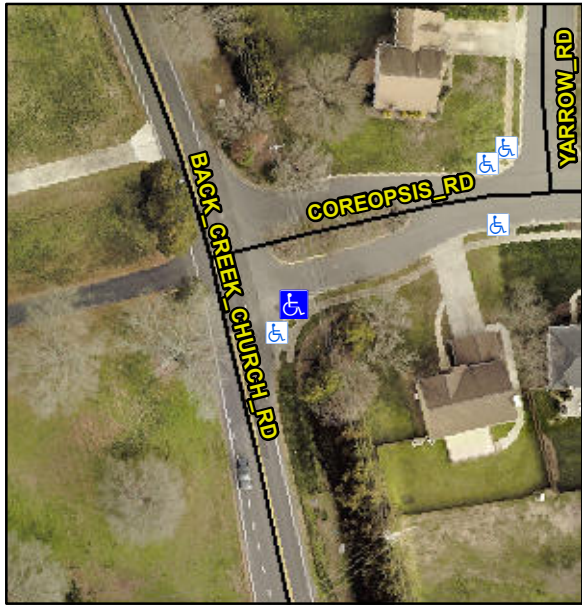
Not Found, R304.2.2, R304.5.3

Compliance	Description	Data	Compliance	Description	Data
N/A	Ramp Length (in)	95.0	No	Ramp Slope (%)	9.6
Yes	Ramp Width (in)	60.0	No	Ramp XSlope (%)	3.7
N/A	Flare Type LT	N/A	N/A	Flare Type RT	N/A
N/A	Flare Slope LT (%)	N/A	N/A	Flare Slope RT (%)	N/A
N/A	Flare Traversable LT?	N/A	N/A	Flare Traversable RT?	N/A
N/A	Landing Length (in)	N/A	N/A	DWS Provided?	N/A
N/A	Landing Width (in)	N/A	N/A	DWS Contrast?	N/A
N/A	Landing Slope (%)	N/A	N/A	DWS Length (in)	N/A
N/A	Landing X Slope (%)	N/A	N/A	DWS Full Width?	N/A
N/A	Landing Curb? (Y/N)	N/A	N/A	DWS Offset (in)	N/A
N/A	Shared Landing?	N/A			
N/A	Gutter Ponding?	N/A	N/A	Gutter Slope (%)	N/A
N/A	Gutter Lip Ht (in)	1.0	N/A	Gutter X Slope (%)	N/A
N/A	Painted X Walk1?	No	N/A	Painted X Walk2?	N/A
	X Walk 1 Direction	To NW		X Walk 2 Direction	N/A
N/A	X Walk 1 Width (in)	N/A	N/A	X Walk 2 Width (in)	N/A
	X Walk 1 Slope (%)	0.3		X Walk 2 Slope (%)	N/A
	X Walk 1 X Slope (%)	2.5		X Walk 2 X Slope (%)	N/A

N/A	Ramp inside XWalk1?	N/A	N/A	Ramp inside XWalk2?	N/A
	Road Slope (%)	N/A	N/A	Clear Space?	N/A
	Road X Slope (%)	N/A	N/A	Clear Space to XWalk (in)	N/A
N/A	Any Obstructions?	N/A	N/A	Storm Grate/Utility Hazard?	N/A
	Obstruction Type			Storm Grate/Utility Type	
		N/A			N/A
			Yes	Surface Condition? (G/P)	Good

Possible Solutions:

Remove & Replace Entire Ramp.

Total Cost:\$1850.00
