## Access Compliance Report Public Rights-of-Way (Curb Ramps)

Intersection ID: 49927 Main Street: ASHBOURNE\_HALL\_RD Cross Street: CAMPBELL\_HALL\_CT Location: SW

ADA ID: 05C19343EE1A Ramp Type: Perp Initial Pass/Fail: Fail Overall Compliance: No Severity Score: 13.75

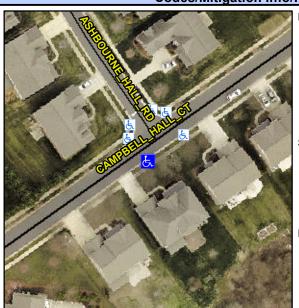
Field Measurements/Component Compliance								
Compl	iance Description	Data	Compl	iance Description	Data			
N/A	Ramp Length (in)	48.0	No	Ramp Slope (%)	10.2			
Yes	Ramp Width (in)	48.0	No	Ramp XSlope (%)	2.8			
N/A	Flare Type LT	N/A	N/A	Flare Type RT	N/A			
N/A	Flare Slope LT (%)	N/A	N/A	Flare Slope RT (%)	N/A			
N/A	Flare Traversable LT?	N/A	N/A	Flare Traversable RT?	N/A			
N/A	Landing Length (in)	N/A	N/A	DWS Provided?	N/A			
N/A	Landing Width (in)	N/A	N/A	DWS Contrast?	N/A			
N/A	Landing Slope (%)	N/A	N/A	DWS Length (in)	N/A			
N/A	Landing X Slope (%)	N/A	N/A	DWS Full Width?	N/A			
N/A	Landing Curb? (Y/N)	N/A	N/A	DWS Offset (in)	N/A			
N/A	Shared Landing?	N/A						
N/A	Gutter Ponding?	N/A	N/A	Gutter Slope (%)	N/A			
N/A	Gutter Lip Ht (in)	N/A	N/A	Gutter X Slope (%)	N/A			
N/A	Painted X Walk1?	No	N/A	Painted X Walk2?	N/A			
	X Walk 1 Direction	To NW		X Walk 2 Direction	N/A			
N/A	X Walk 1 Width (in)	N/A	N/A	X Walk 2 Width (in)	N/A

X Walk 1 Slope (%)	2.2		X Walk 2 Slope (%)	N/A			
	X Walk 1 X Slope (%)	1.9		X Walk 2 X Slope (%)	N/A			
N/A	Ramp inside XWalk1?	N/A	N/A	Ramp inside XWalk2?	N/A			
	Road Slope (%)	N/A	N/A	Clear Space?	N/A			
	Road X Slope (%)	N/A	N/A	Clear Space to XWalk (in)	N/A			
N/A	Any Obstructions?	N/A	N/A	Storm Grate/Utility Hazard?	N/A			
	Obstruction Type			Storm Grate/Utility Type				
		N/A			N/A			
			Yes	Surface Condition? (G/P)	Good

/Possible Solution	
Possible Solutions:	<u>c</u>
Remove & Replace Entire Ramp.	N
· · · · · · · · · · · · · · · · · · ·	Y
	N
	N
	N
	N
Surveyor Notes:	N
N/A	N
	N
	N
	N
PROW/ADA:	N
R304.2.2, R304.5.3	N
,	N
	N
