Access Compliance Report

Public Rights-of-Way

(Curb Ramps)

Intersection ID: 14011	Main Street: WEST_BV	Cross Street: ROMARE_BEARDEN_DR	Location: SE
ADA ID: 05CFE1AA9FF4	Ramp Type: PerpDiag	Initial Pass/Fail: Fail	Overall Compliance: No
		Severity Score: 10

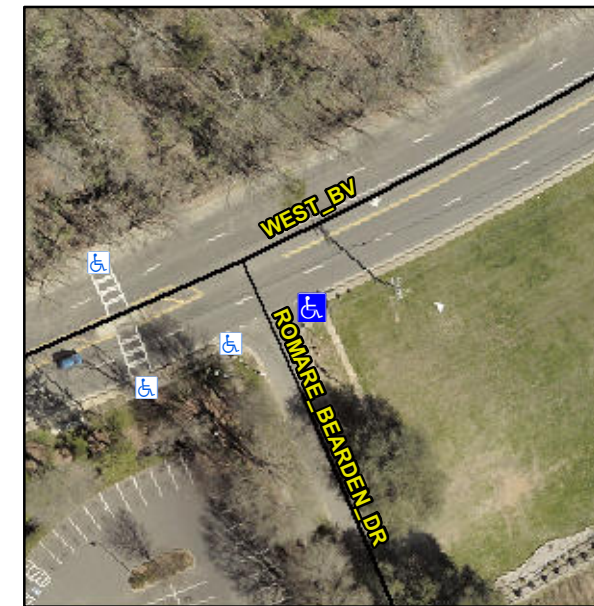
Not Found, R304.5.1, R304.5.3

Compliance	Description	Data	Compliance	Description	Data
N/A	Ramp Length (in)	46.6	Yes	Ramp Slope (%)	6.8
No	Ramp Width (in)	44.0	No	Ramp XSlope (%)	3.0
N/A	Flare Type LT	N/A	N/A	Flare Type RT	N/A
N/A	Flare Slope LT (%)	N/A	N/A	Flare Slope RT (%)	N/A
N/A	Flare Traversable LT?	N/A	N/A	Flare Traversable RT?	N/A
N/A	Landing Length (in)	N/A	N/A	DWS Provided?	N/A
N/A	Landing Width (in)	N/A	N/A	DWS Contrast?	N/A
N/A	Landing Slope (%)	N/A	N/A	DWS Length (in)	N/A
N/A	Landing X Slope (%)	N/A	N/A	DWS Full Width?	N/A
N/A	Landing Curb? (Y/N)	N/A	N/A	DWS Offset (in)	N/A
N/A	Shared Landing?	N/A			
N/A	Gutter Ponding?	N/A	N/A	Gutter Slope (%)	N/A
N/A	Gutter Lip Ht (in)	N/A	N/A	Gutter X Slope (%)	N/A
N/A	Painted X Walk1?	No	N/A	Painted X Walk2?	No
	X Walk 1 Direction	To N		X Walk 2 Direction	To W
N/A	X Walk 1 Width (in)	N/A	N/A	X Walk 2 Width (in)	N/A
	X Walk 1 Slope (%)	8.1		X Walk 2 Slope (%)	4.1
	X Walk 1 X Slope (%)	1.2		X Walk 2 X Slope (%)	3.3

N/A	Ramp inside XWalk1?	N/A	N/A	Ramp inside XWalk2?	N/A
	Road Slope (%)	1.2	N/A	Clear Space?	N/A
	Road X Slope (%)	4.4	N/A	Clear Space to XWalk (in)	N/A
N/A	Any Obstructions?	N/A	N/A	Storm Grate/Utility Hazard?	N/A
	Obstruction Type			Storm Grate/Utility Type	
		N/A			N/A
		Yes		Surface Condition? (G/P)	Good

Remove & Replace Curb Ramp With Two New Directional Ramps or Equivalent.
