Access Compliance Report

Public Rights-of-Way

(Curb Ramps)

Intersection ID: 15605	Main Street: GREYSTONE_RD	Cross Street: SOUTH_BV	Location: SW
ADA ID: 05E421F9AC2B	Ramp Type: Perp	Initial Pass/Fail: Fail	Overall Compliance: No
		Severity Score: 8.75	
Codes/Mitigation Info/Possible Solution		Field Measurements/Component Compliance

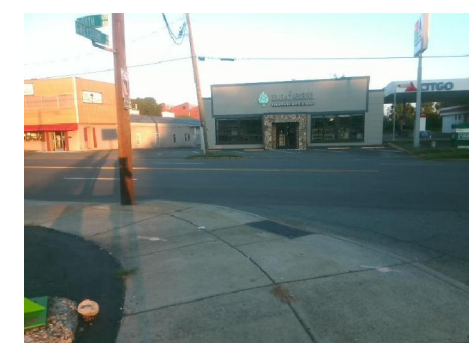
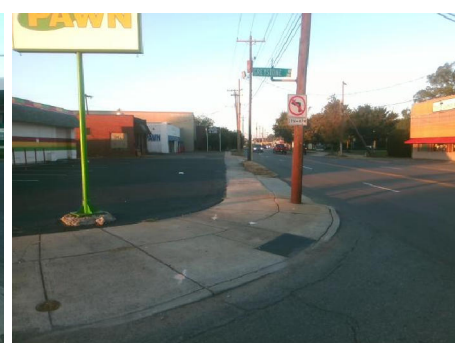
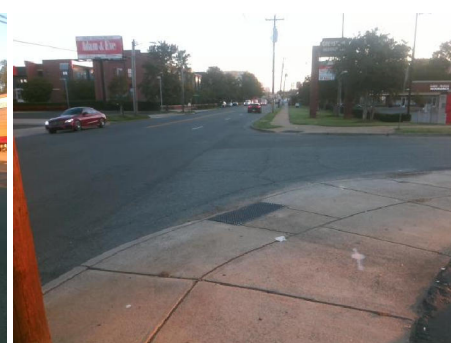
Not Found, R304.5.1

Compliance	Description	Data	Compliance	Description	Data
N/A	Ramp Length (in)	63.0	Yes	Ramp Slope (%)	7.2
No	Ramp Width (in)	36.0	Yes	Ramp XSlope (%)	1.3
N/A	Flare Type LT	N/A	N/A	Flare Type RT	N/A
N/A	Flare Slope LT (%)	N/A	N/A	Flare Slope RT (%)	N/A
N/A	Flare Traversable LT?	N/A	N/A	Flare Traversable RT?	N/A
N/A	Landing Length (in)	N/A	N/A	DWS Provided?	N/A
N/A	Landing Width (in)	N/A	N/A	DWS Contrast?	N/A
N/A	Landing Slope (%)	N/A	N/A	DWS Length (in)	N/A
N/A	Landing X Slope (%)	N/A	N/A	DWS Full Width?	N/A
N/A	Landing Curb? (Y/N)	N/A	N/A	DWS Offset (in)	N/A
N/A	Shared Landing?	N/A			
N/A	Gutter Ponding?	N/A	N/A	Gutter Slope (%)	N/A
N/A	Gutter Lip Ht (in)	N/A	N/A	Gutter X Slope (%)	N/A
N/A	Painted X Walk1?	No	N/A	Painted X Walk2?	N/A
	X Walk 1 Direction	To NE		X Walk 2 Direction	N/A
N/A	X Walk 1 Width (in)	N/A	N/A	X Walk 2 Width (in)	N/A
	X Walk 1 Slope (%)	1.1		X Walk 2 Slope (%)	N/A
	X Walk 1 X Slope (%)	1.1		X Walk 2 X Slope (%)	N/A

N/A	Ramp inside XWalk1?	N/A	N/A	Ramp inside XWalk2?	N/A
	Road Slope (%)	N/A	N/A	Clear Space?	N/A
	Road X Slope (%)	N/A	N/A	Clear Space to XWalk (in)	N/A
N/A	Any Obstructions?	N/A	N/A	Storm Grate/Utility Hazard?	N/A
	Obstruction Type			Storm Grate/Utility Type	
		N/A			N/A
			Yes	Surface Condition? (G/P)	Good

Remove & Replace Entire Ramp.
