Access Compliance Report

Public Rights-of-Way

(Curb Ramps)

Intersection ID: 12066	Main Street: WEYLAND_AV	Cross Street: MARLOWE_AV	Location: NW
ADA ID: 05E50B2327A3	Ramp Type: PerpDiag	Initial Pass/Fail: Fail	Overall Compliance: No
Codes/Mitigation Info/Possible Solution		Field Measurements/Component Compliance

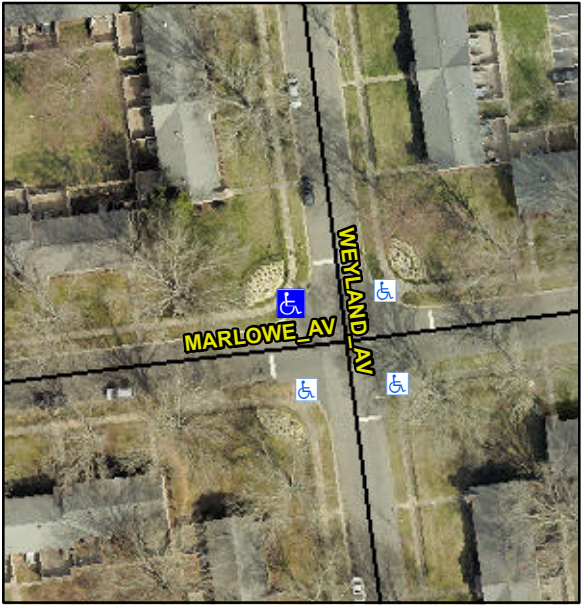
Possible Solutions:	Compliance	Description	Data	Compliance	Description	Data
	Remove & Replace Curb Ramp With Two New Directional Ramps or Equivalent.	N/A	Ramp Length (in)	72.5	No	Ramp Slope (%)	9.5
<p>Surveyor Notes:</p> <p>N/A</p> <p>PROW/ADA:</p> <p>Not Found, R304.5.1, R304.2.2, R304.5.3</p>		No	Ramp Width (in)	42.5	No	Ramp XSlope (%)	3.1
		N/A	Flare Type LT	N/A	N/A	Flare Type RT	N/A
		N/A	Flare Slope LT (%)	N/A	N/A	Flare Slope RT (%)	N/A
		N/A	Flare Traversable LT?	N/A	N/A	Flare Traversable RT?	N/A
		N/A	Landing Length (in)	N/A	N/A	DWS Provided?	N/A
		N/A	Landing Width (in)	N/A	N/A	DWS Contrast?	N/A
		N/A	Landing Slope (%)	N/A	N/A	DWS Length (in)	N/A
		N/A	Landing X Slope (%)	N/A	N/A	DWS Full Width?	N/A
		N/A	Landing Curb? (Y/N)	N/A	N/A	DWS Offset (in)	N/A
		N/A	Shared Landing?	N/A			
		N/A	Gutter Ponding?	N/A	N/A	Gutter Slope (%)	N/A
		N/A	Gutter Lip Ht (in)	N/A	N/A	Gutter X Slope (%)	N/A
		N/A	Painted X Walk1?	No	N/A	Painted X Walk2?	No

X Walk 1 Direction	To S		X Walk 2 Direction	To E
		N/A	X Walk 1 Width (in)	N/A	N/A	X Walk 2 Width (in)	N/A
			X Walk 1 Slope (%)	2.6		X Walk 2 Slope (%)	2.4
			X Walk 1 X Slope (%)	1.9		X Walk 2 X Slope (%)	0.2
		N/A	Ramp inside XWalk1?	N/A	N/A	Ramp inside XWalk2?	N/A
			Road Slope (%)	1.3	N/A	Clear Space?	N/A
			Road X Slope (%)	3.1	N/A	Clear Space to XWalk (in)	N/A
		N/A	Any Obstructions?	N/A	N/A	Storm Grate/Utility Hazard?	N/A
			Obstruction Type			Storm Grate/Utility Type	
				N/A			N/A
					Yes	Surface Condition? (G/P)	Good
Total Cost:		\$	3200.00
