# Access Compliance Report

## Public Rights-of-Way

### (Curb Ramps)

Intersection ID: 12194	Main Street: S_CEDAR_ST	Cross Street: W_HILL_ST	Location: E
ADA ID: 05EBBF5E0E83	Ramp Type: PerpDiag	Initial Pass/Fail: Fail	Overall Compliance: No
		Severity Score: 10

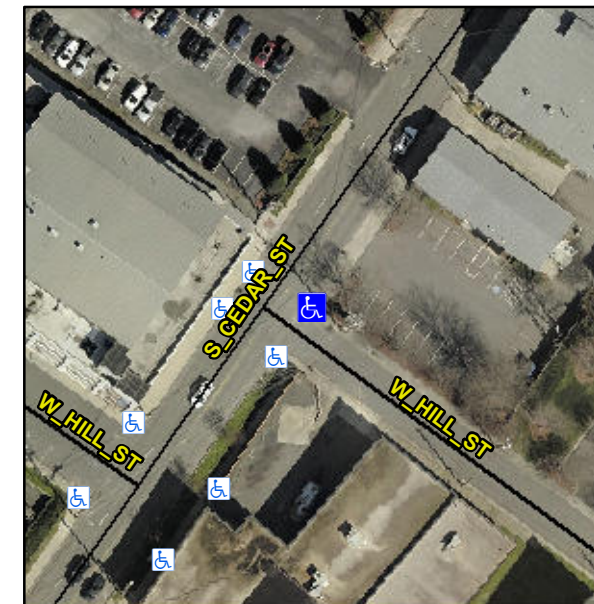
Compliance	Description	Data	Compliance	Description	Data
N/A	Ramp Length (in)	60.0	Yes	Ramp Slope (%)	6.4
No	Ramp Width (in)	36.0	No	Ramp XSlope (%)	3.6
N/A	Flare Type LT	N/A	N/A	Flare Type RT	N/A
N/A	Flare Slope LT (%)	N/A	N/A	Flare Slope RT (%)	N/A
N/A	Flare Traversable LT?	N/A	N/A	Flare Traversable RT?	N/A
N/A	Landing Length (in)	N/A	N/A	DWS Provided?	N/A
N/A	Landing Width (in)	N/A	N/A	DWS Contrast?	N/A
N/A	Landing Slope (%)	N/A	N/A	DWS Length (in)	N/A
N/A	Landing X Slope (%)	N/A	N/A	DWS Full Width?	N/A
N/A	Landing Curb? (Y/N)	N/A	N/A	DWS Offset (in)	N/A
N/A	Shared Landing?	N/A			
N/A	Gutter Ponding?	N/A	N/A	Gutter Slope (%)	N/A
N/A	Gutter Lip Ht (in)	N/A	N/A	Gutter X Slope (%)	N/A
N/A	Painted X Walk1?	No	N/A	Painted X Walk2?	No
	X Walk 1 Direction	To NW		X Walk 2 Direction	To SW
N/A	X Walk 1 Width (in)	N/A	N/A	X Walk 2 Width (in)	N/A
	X Walk 1 Slope (%)	4.2		X Walk 2 Slope (%)	3.2
	X Walk 1 X Slope (%)	1.9		X Walk 2 X Slope (%)	1.8

N/A	Ramp inside XWalk1?	N/A	N/A	Ramp inside XWalk2?	N/A
	Road Slope (%)	0.2	N/A	Clear Space?	N/A
	Road X Slope (%)	2.9	N/A	Clear Space to XWalk (in)	N/A
N/A	Any Obstructions?	N/A	N/A	Storm Grate/Utility Hazard?	N/A
	Obstruction Type			Storm Grate/Utility Type	
		N/A			N/A
		Yes		Surface Condition? (G/P)	Good

**Remove & Replace Curb Ramp With Two New Directional Ramps or Equivalent.**

**R304.5.1, R304.5.3**
