# Access Compliance Report

## Public Rights-of-Way

### (Curb Ramps)

Intersection ID: 31872	Main Street: LANGDEN_GATE_DR	Cross Street: TAPESTRY_WOODS_CT	Location: SE
ADA ID: 05F18DF20CAB	Ramp Type: PerpDiag	Initial Pass/Fail: Fail	Overall Compliance: No
Severity Score: 33.75			
Codes/Mitigation Info/Possible Solution		Field Measurements/Component Compliance

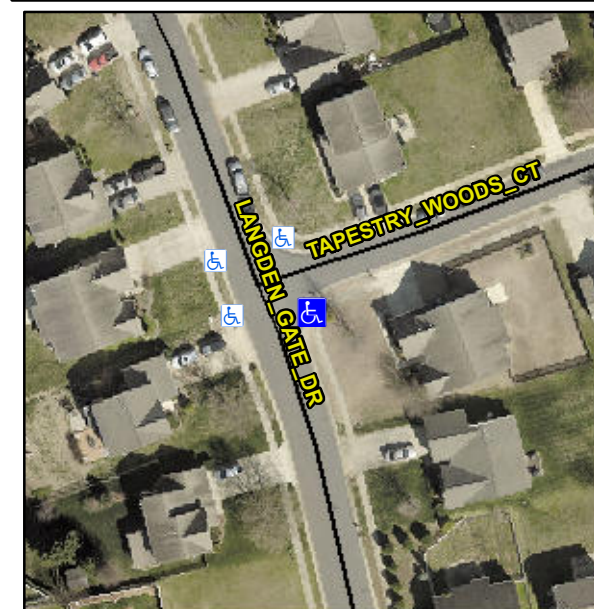
**R304.5.1, R304.5.3**

Compliance	Description	Data	Compliance	Description	Data
N/A	Ramp Length (in)	48.0	Yes	Ramp Slope (%)	5.5
No	Ramp Width (in)	41.0	No	Ramp XSlope (%)	8.5
N/A	Flare Type LT	N/A	N/A	Flare Type RT	N/A
N/A	Flare Slope LT (%)	N/A	N/A	Flare Slope RT (%)	N/A
N/A	Flare Traversable LT?	N/A	N/A	Flare Traversable RT?	N/A
N/A	Landing Length (in)	N/A	N/A	DWS Provided?	N/A
N/A	Landing Width (in)	N/A	N/A	DWS Contrast?	N/A
N/A	Landing Slope (%)	N/A	N/A	DWS Length (in)	N/A
N/A	Landing X Slope (%)	N/A	N/A	DWS Full Width?	N/A
N/A	Landing Curb? (Y/N)	N/A	N/A	DWS Offset (in)	N/A
N/A	Shared Landing?	N/A			
N/A	Gutter Ponding?	N/A	N/A	Gutter Slope (%)	N/A
N/A	Gutter Lip Ht (in)	N/A	N/A	Gutter X Slope (%)	N/A
N/A	Painted X Walk1?	No	N/A	Painted X Walk2?	No
	X Walk 1 Direction	To NW		X Walk 2 Direction	To W
N/A	X Walk 1 Width (in)	N/A	N/A	X Walk 2 Width (in)	N/A
	X Walk 1 Slope (%)	3.2		X Walk 2 Slope (%)	0.3
	X Walk 1 X Slope (%)	2.5		X Walk 2 X Slope (%)	3.5

N/A	Ramp inside XWalk1?	N/A	N/A	Ramp inside XWalk2?	N/A
	Road Slope (%)	4.3	N/A	Clear Space?	N/A
	Road X Slope (%)	1.1	N/A	Clear Space to XWalk (in)	N/A
N/A	Any Obstructions?	N/A	N/A	Storm Grate/Utility Hazard?	N/A
	Obstruction Type			Storm Grate/Utility Type	
		N/A			N/A
			Yes	Surface Condition? (G/P)	Good

**Remove & Replace Curb Ramp With Two New Directional Ramps or Equivalent.**

Total Cost: \$ 3200.00
