Access Compliance Report

Public Rights-of-Way

(Curb Ramps)

Intersection ID: 24585	Main Street: REA_CROFT_DR	Cross Street: REA_RD	Location: SW
ADA ID: 05F673B112DA	Ramp Type: Perp	Initial Pass/Fail: Pass	Overall Compliance: No
		Severity Score: 0

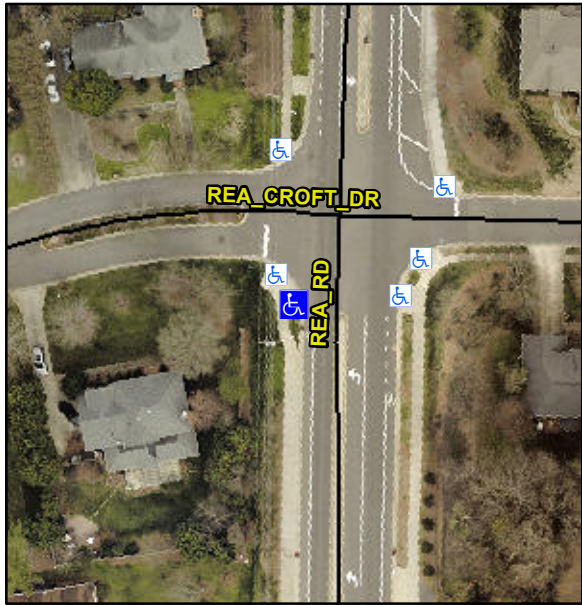
Possible Solutions:		Compliance			Description			Data	Compliance			Description			Data
	Remove & Replace Entire Ramp.		N/A	Ramp Length (in)			65.0			Yes	Ramp Slope (%)			6.4		
			Yes	Ramp Width (in)			48.0			Yes	Ramp XSlope (%)			1.5		
			N/A	Flare Type LT			Sloped			N/A	Flare Type RT			N/A		
			N/A	Flare Slope LT (%)			2.1			Yes	Flare Slope RT (%)			9.8		
			N/A	Flare Traversable LT?			Yes			N/A	Flare Traversable RT?			Yes		
			Yes	Landing Length (in)			74.0			Yes	DWS Provided?			Yes		
			Yes	Landing Width (in)			48.0			Yes	DWS Contrast?			Yes		
			Yes	Landing Slope (%)			0.7			Yes	DWS Length (in)			24.0		
			Yes	Landing X Slope (%)			1.0			Yes	DWS Full Width?			Yes		
Surveyor Notes:		N/A	N/A	Landing Curb? (Y/N)			No			Yes	DWS Offset (in)			1.0		
			N/A	Shared Landing?			No									
PROW/ADA:		Not Found	Yes	Gutter Ponding?			No			Yes	Gutter Slope (%)			0.4

Yes	Gutter Lip Ht (in)			0.0			Yes	Gutter X Slope (%)			2.0		
			N/A	Painted X Walk1?			No			N/A	Painted X Walk2?			N/A		
				X Walk 1 Direction			To E				X Walk 2 Direction			N/A		
			N/A	X Walk 1 Width (in)			N/A			N/A	X Walk 2 Width (in)			N/A		
				X Walk 1 Slope (%)			2.8				X Walk 2 Slope (%)			N/A		
				X Walk 1 X Slope (%)			2.3				X Walk 2 X Slope (%)			N/A		
Street 1 Name		REA RD	N/A	Ramp inside XWalk1?			N/A			N/A	Ramp inside XWalk2?			N/A		
Stop Condition-Street 2		None		Road Slope (%)			N/A			N/A	Clear Space?			Yes		
Street 2 Name		N/A		Road X Slope (%)			N/A			N/A	Clear Space to XWalk (in)			N/A		
Stop Condition-Street 1		N/A	Yes	Any Obstructions?			No			Yes	Storm Grate/Utility Hazard?			No		
				Obstruction Type							Storm Grate/Utility Type					
										N/A				N/A		
										Yes	Surface Condition? (G/P)			Good		
Total Cost:		\$ 1850.00
