Access Compliance Report Public Rights-of-Way (Curb Ramps)

Intersection ID: 13197 Main Street: S_MCDOWELL_ST Cross Street: E_4TH_ST Location: W

ADA ID: 05F7E02E4699 Ramp Type: Perp Initial Pass/Fail: Fail Overall Compliance: No Severity Score: 13.75

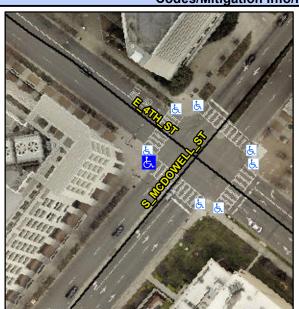
| Possible Solutions: | | | | | | |
|---|--|--|--|--|--|--|
| Not Found, R304.2.2, R304.5.3 | | | | | | |

| Field Measurements/Component Compliance | | | | | | | |
|---|---|---|---|---|---|---|--|
| | N/A | Ramp Length (in) | 60.0 | No | Ramp Slope (%) | 11.1 | |
| | Yes | Ramp Width (in) | 49.0 | No | Ramp XSlope (%) | 2.3 | |

| Possible Solutions: | | | | | | |
|---|--|--|--|--|--|--|
| Remove & Replace Entire Ramp. | | | | | | |

Total Cost: \$ 1850.00
