Access Compliance Report

Public Rights-of-Way

(Curb Ramps)

Intersection ID: 9810	Main Street: BRIDGEPORT_DR	Cross Street: THE_PLAZA	Location:	N
ADA ID: 05F8E9E336DB	Ramp Type: Perp	Initial Pass/Fail: Fail	Overall Compliance: No	Severity Score: 37.5
Codes/Mitigation Info/Possible Solution		Field Measurements/Component Compliance

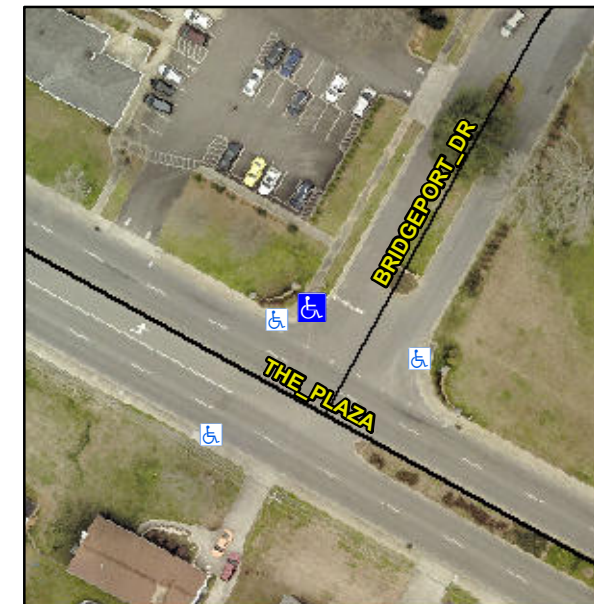
Compliance	Description	Data	Compliance	Description	Data
N/A	Ramp Length (in)	60.0	No	Ramp Slope (%)	9.1
Yes	Ramp Width (in)	48.0	No	Ramp XSlope (%)	7.6
N/A	Flare Type LT	N/A	N/A	Flare Type RT	N/A
N/A	Flare Slope LT (%)	N/A	N/A	Flare Slope RT (%)	N/A
N/A	Flare Traversable LT?	N/A	N/A	Flare Traversable RT?	N/A
N/A	Landing Length (in)	N/A	N/A	DWS Provided?	N/A
N/A	Landing Width (in)	N/A	N/A	DWS Contrast?	N/A
N/A	Landing Slope (%)	N/A	N/A	DWS Length (in)	N/A
N/A	Landing X Slope (%)	N/A	N/A	DWS Full Width?	N/A
N/A	Landing Curb? (Y/N)	N/A	N/A	DWS Offset (in)	N/A
N/A	Shared Landing?	N/A			
N/A	Gutter Ponding?	N/A	N/A	Gutter Slope (%)	N/A
N/A	Gutter Lip Ht (in)	N/A	N/A	Gutter X Slope (%)	N/A
N/A	Painted X Walk1?	No	N/A	Painted X Walk2?	N/A
	X Walk 1 Direction	To SE		X Walk 2 Direction	N/A
N/A	X Walk 1 Width (in)	N/A	N/A	X Walk 2 Width (in)	N/A
	X Walk 1 Slope (%)	2.9		X Walk 2 Slope (%)	N/A
	X Walk 1 X Slope (%)	4.1		X Walk 2 X Slope (%)	N/A

N/A	Ramp inside XWalk1?	N/A	N/A	Ramp inside XWalk2?	N/A
	Road Slope (%)	N/A	N/A	Clear Space?	N/A
	Road X Slope (%)	N/A	N/A	Clear Space to XWalk (in)	N/A
N/A	Any Obstructions?	N/A	N/A	Storm Grate/Utility Hazard?	N/A
	Obstruction Type			Storm Grate/Utility Type	
		N/A			N/A
			Yes	Surface Condition? (G/P)	Good

Possible Solutions:

Remove & Replace Entire Ramp.

R304.2.2, R304.5.3
