Access Compliance Report

Public Rights-of-Way

(Curb Ramps)

Intersection ID: 8854	Main Street: BARRINGTON_DR	Cross Street: TREELINE_PL	Location: S
ADA ID: 05FE5FAA0D6B	Ramp Type: Perp	Initial Pass/Fail: Fail	Overall Compliance: No
Severity Score: 1.25			
Codes/Mitigation Info/Possible Solution		Field Measurements/Component Compliance

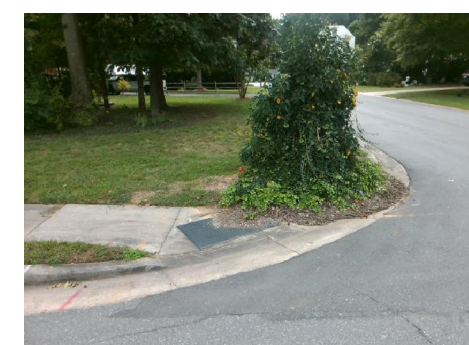
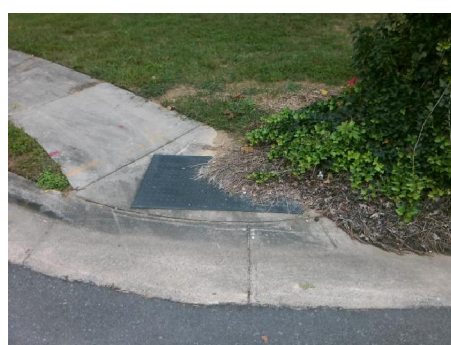
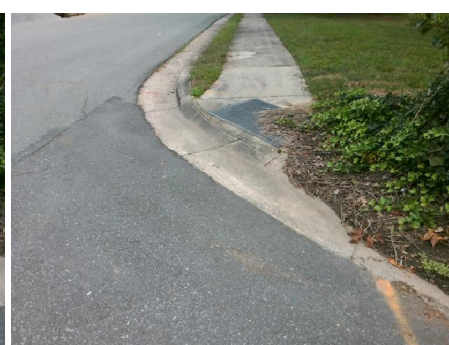
Not Found, R304.5.3

Compliance	Description	Data	Compliance	Description	Data
N/A	Ramp Length (in)	30.0	Yes	Ramp Slope (%)	7.2
Yes	Ramp Width (in)	48.0	No	Ramp XSlope (%)	3.0
N/A	Flare Type LT	N/A	N/A	Flare Type RT	N/A
N/A	Flare Slope LT (%)	N/A	N/A	Flare Slope RT (%)	N/A
N/A	Flare Traversable LT?	N/A	N/A	Flare Traversable RT?	N/A
N/A	Landing Length (in)	N/A	N/A	DWS Provided?	N/A
N/A	Landing Width (in)	N/A	N/A	DWS Contrast?	N/A
N/A	Landing Slope (%)	N/A	N/A	DWS Length (in)	N/A
N/A	Landing X Slope (%)	N/A	N/A	DWS Full Width?	N/A
N/A	Landing Curb? (Y/N)	N/A	N/A	DWS Offset (in)	N/A
N/A	Shared Landing?	N/A			
N/A	Gutter Ponding?	N/A	N/A	Gutter Slope (%)	N/A
N/A	Gutter Lip Ht (in)	1.0	N/A	Gutter X Slope (%)	N/A
N/A	Painted X Walk1?	No	N/A	Painted X Walk2?	N/A
	X Walk 1 Direction	To NW		X Walk 2 Direction	N/A
N/A	X Walk 1 Width (in)	N/A	N/A	X Walk 2 Width (in)	N/A
	X Walk 1 Slope (%)	0.5		X Walk 2 Slope (%)	N/A
	X Walk 1 X Slope (%)	4.5		X Walk 2 X Slope (%)	N/A

N/A	Ramp inside XWalk1?	N/A	N/A	Ramp inside XWalk2?	N/A
	Road Slope (%)	N/A	N/A	Clear Space?	N/A
	Road X Slope (%)	N/A	N/A	Clear Space to XWalk (in)	N/A
N/A	Any Obstructions?	N/A	N/A	Storm Grate/Utility Hazard?	N/A
	Obstruction Type			Storm Grate/Utility Type	
		N/A			N/A
		Yes		Surface Condition? (G/P)	Good

Remove & Replace Entire Ramp.
