Access Compliance Report

Public Rights-of-Way

(Curb Ramps)

Intersection ID: 50485	Main Street: JONES_CROSSING_RD	Cross Street: HAWFIELD_WAY_DR	Location: SE
ADA ID: 060C5DF78AFB	Ramp Type: Perp	Initial Pass/Fail: Fail	Overall Compliance: No
Codes/Mitigation Info/Possible Solution			Severity Score: 10
			Field Measurements/Component Compliance

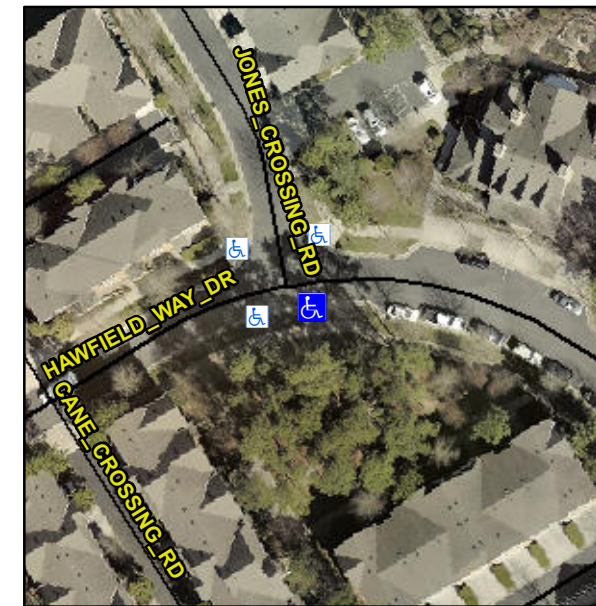
Not Found, R304.5.1

Compliance	Description	Data	Compliance	Description	Data
N/A	Ramp Length (in)	94.5	Yes	Ramp Slope (%)	8.0
No	Ramp Width (in)	47.0	Yes	Ramp XSlope (%)	4.2
N/A	Flare Type LT	N/A	N/A	Flare Type RT	N/A
N/A	Flare Slope LT (%)	N/A	N/A	Flare Slope RT (%)	N/A
N/A	Flare Traversable LT?	N/A	N/A	Flare Traversable RT?	N/A
N/A	Landing Length (in)	N/A	N/A	DWS Provided?	N/A
N/A	Landing Width (in)	N/A	N/A	DWS Contrast?	N/A
N/A	Landing Slope (%)	N/A	N/A	DWS Length (in)	N/A
N/A	Landing X Slope (%)	N/A	N/A	DWS Full Width?	N/A
N/A	Landing Curb? (Y/N)	N/A	N/A	DWS Offset (in)	N/A
N/A	Shared Landing?	N/A			
N/A	Gutter Ponding?	N/A	N/A	Gutter Slope (%)	N/A
N/A	Gutter Lip Ht (in)	N/A	N/A	Gutter X Slope (%)	N/A
N/A	Painted X Walk1?	No	N/A	Painted X Walk2?	N/A
	X Walk 1 Direction	To N		X Walk 2 Direction	N/A
N/A	X Walk 1 Width (in)	N/A	N/A	X Walk 2 Width (in)	N/A
	X Walk 1 Slope (%)	1.5		X Walk 2 Slope (%)	N/A
	X Walk 1 X Slope (%)	4.7		X Walk 2 X Slope (%)	N/A

N/A	Ramp inside XWalk1?	N/A	N/A	Ramp inside XWalk2?	N/A
	Road Slope (%)	N/A	N/A	Clear Space?	N/A
	Road X Slope (%)	N/A	N/A	Clear Space to XWalk (in)	N/A
N/A	Any Obstructions?	N/A	N/A	Storm Grate/Utility Hazard?	N/A
	Obstruction Type			Storm Grate/Utility Type	
		N/A			N/A
			Yes	Surface Condition? (G/P)	Good

Possible Solutions:

Remove & Replace Entire Ramp.
