Access Compliance Report

Public Rights-of-Way

(Curb Ramps)

Intersection ID: 27321	Main Street: OWL_NEST_LN	Cross Street: STANETTE_DR	Location: SE
ADA ID: 060EC8308D17	Ramp Type: BlendTrans2	Initial Pass/Fail: Fail	Overall Compliance: No
		Severity Score: 25

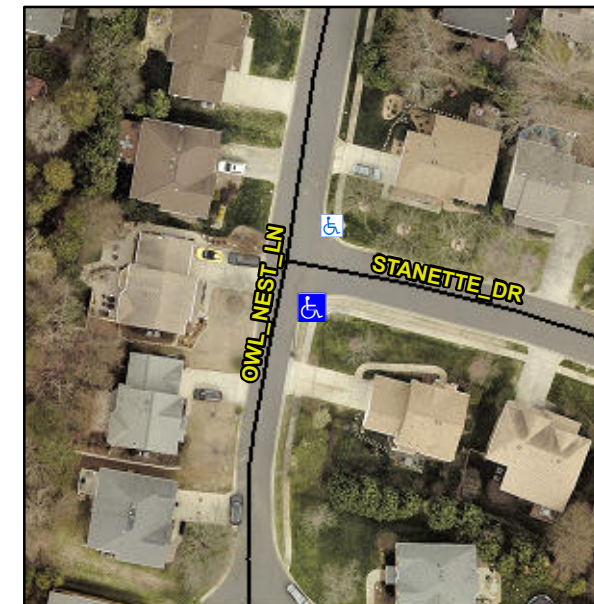
Compliance	Description	Data	Compliance	Description	Data
N/A	Ramp Length (in)	93.5	Yes	BlendTrans Slope (%)	3.9
Yes	Ramp Width (in)	48.0	No	BlendTrans XSlope (%)	10.9
N/A	Flare Type LT	N/A	N/A	Flare Type RT	N/A
N/A	Flare Slope LT (%)	N/A	N/A	Flare Slope RT (%)	N/A
N/A	Flare Traversable LT?	N/A	N/A	Flare Traversable RT?	N/A
N/A	Landing Length (in)	N/A	N/A	DWS Provided?	N/A
N/A	Landing Width (in)	N/A	N/A	DWS Contrast?	N/A
N/A	Landing Slope (%)	N/A	N/A	DWS Length (in)	N/A
N/A	Landing X Slope (%)	N/A	N/A	DWS Full Width?	N/A
N/A	Landing Curb? (Y/N)	N/A	N/A	DWS Offset (in)	N/A
N/A	Shared Landing?	N/A			
N/A	Gutter Ponding?	N/A	N/A	Gutter Slope (%)	N/A
N/A	Gutter Lip Ht (in)	N/A	N/A	Gutter X Slope (%)	N/A
N/A	Painted X Walk1?	No	N/A	Painted X Walk2?	No
	X Walk 1 Direction	To N		X Walk 2 Direction	To W
	X Walk 1 Width (in)	N/A		X Walk 2 Width (in)	N/A
	X Walk 1 Slope (%)	3.4		X Walk 2 Slope (%)	2.1
	X Walk 1 X Slope (%)	2.8		X Walk 2 X Slope (%)	7.9

N/A	Ramp inside XWalk1?	N/A	N/A	Ramp inside XWalk2?	N/A
	Road Slope (%)	7.9		Clear Space?	N/A
	Road X Slope (%)	3.6	N/A	Clear Space to XWalk (in)	N/A
N/A	Any Obstructions?	N/A	N/A	Storm Grate/Utility Hazard?	N/A
	Obstruction Type			Storm Grate/Utility Type	
		N/A			N/A
			Yes	Surface Condition? (G/P)	Good
			No	Curb Slope (%)	10.6

Possible Solutions:

Remove & Replace Curb Ramp With Two New Directional Ramps or Equivalent.
