Intersection ID: 42963	Main Street: RED_ROBIN_ST	Cross Street: PRAIRIEGROUSE_CT	Location:	N
ADA ID: 061B0AD4DD9D	Ramp Type: PerpDiag	Initial Pass/Fail: Fail	Overall Compliance: No	Severity Score: 46.25

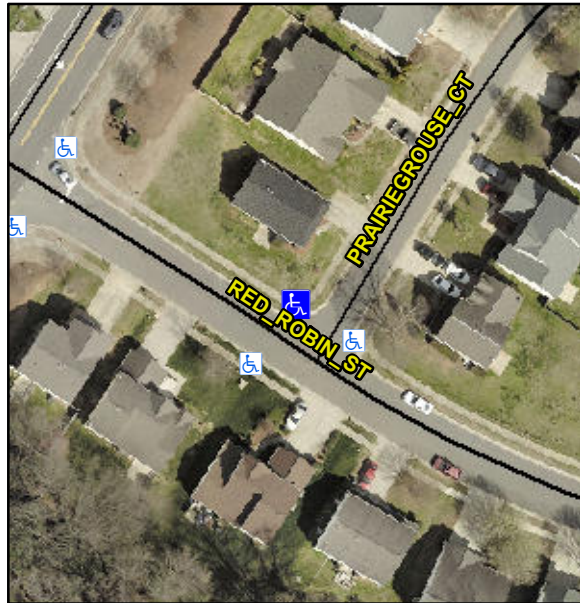
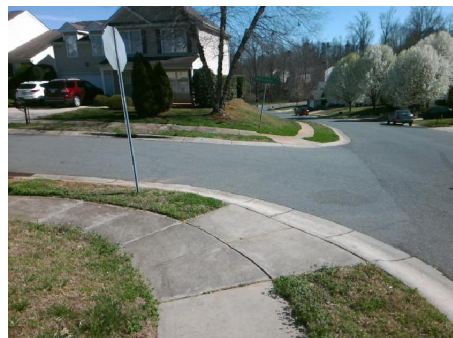
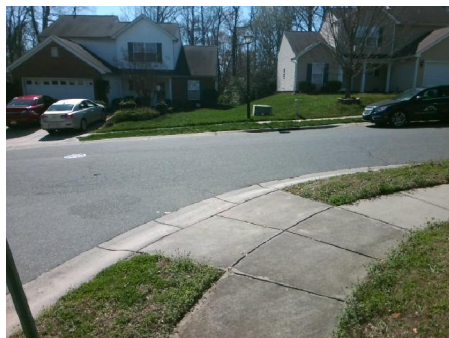
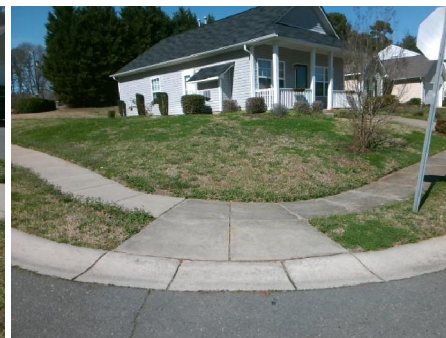
**Not Found, R304.5.1, R304.2.2,  
R304.5.3**

Compliance	Description	Data	Compliance	Description	Data
N/A	Ramp Length (in)	49.5	No	Ramp Slope (%)	8.6
No	Ramp Width (in)	45.0	No	Ramp XSlope (%)	8.6
N/A	Flare Type LT	N/A	N/A	Flare Type RT	N/A
N/A	Flare Slope LT (%)	N/A	N/A	Flare Slope RT (%)	N/A
N/A	Flare Traversable LT?	N/A	N/A	Flare Traversable RT?	N/A
N/A	Landing Length (in)	N/A	N/A	DWS Provided?	N/A
N/A	Landing Width (in)	N/A	N/A	DWS Contrast?	N/A
N/A	Landing Slope (%)	N/A	N/A	DWS Length (in)	N/A
N/A	Landing X Slope (%)	N/A	N/A	DWS Full Width?	N/A
N/A	Landing Curb? (Y/N)	N/A	N/A	DWS Offset (in)	N/A
N/A	Shared Landing?	N/A			
N/A	Gutter Ponding?	N/A	N/A	Gutter Slope (%)	N/A
N/A	Gutter Lip Ht (in)	N/A	N/A	Gutter X Slope (%)	N/A
N/A	Painted X Walk1?	No	N/A	Painted X Walk2?	No
	X Walk 1 Direction	To SW		X Walk 2 Direction	To SE
N/A	X Walk 1 Width (in)	N/A	N/A	X Walk 2 Width (in)	N/A
	X Walk 1 Slope (%)	2.8		X Walk 2 Slope (%)	4.9
	X Walk 1 X Slope (%)	7.9		X Walk 2 X Slope (%)	0.1

N/A	Ramp inside XWalk1?	N/A	N/A	Ramp inside XWalk2?	N/A
	Road Slope (%)	4.1	N/A	Clear Space?	N/A
	Road X Slope (%)	5.8	N/A	Clear Space to XWalk (in)	N/A
N/A	Any Obstructions?	N/A	N/A	Storm Grate/Utility Hazard?	N/A
	Obstruction Type			Storm Grate/Utility Type	
		N/A			N/A
			Yes	Surface Condition? (G/P)	Good

**Remove & Replace Curb Ramp With Two New Directional Ramps or Equivalent.**

Total Cost: \$ 3200.00
