# Access Compliance Report

## Public Rights-of-Way

### (Curb Ramps)

Intersection ID: 10036601	Main Street: RUSHMORE_DR	Cross Street: N/A	Location:	E
ADA ID: 062D65E28CD5	Ramp Type: Perp	Initial Pass/Fail: Fail	Overall Compliance: No	Severity Score: 12.5

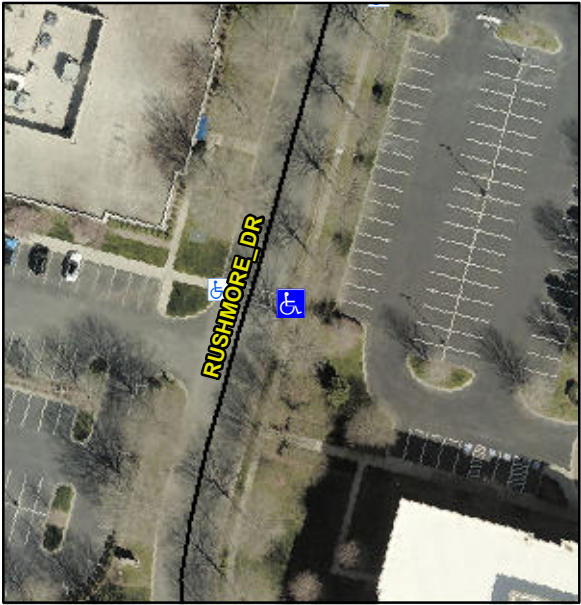
Possible Solutions:		<b>Compliance</b>	<b>Description</b>	<b>Data</b>	
	<b>Remove &amp; Replace Entire Ramp.</b>		<b>N/A</b>	Ramp Length (in)	<b>55.0</b>	<b>No</b>
			<b>Yes</b>	Ramp Width (in)	<b>48.0</b>	<b>Yes</b>
			<b>N/A</b>	Flare Type LT	<b>N/A</b>	<b>N/A</b>
			<b>N/A</b>	Flare Slope LT (%)	<b>N/A</b>	<b>N/A</b>
			<b>N/A</b>	Flare Traversable LT?	<b>N/A</b>	<b>N/A</b>
			<b>N/A</b>	Landing Length (in)	<b>N/A</b>	<b>N/A</b>
			<b>N/A</b>	Landing Width (in)	<b>N/A</b>	<b>N/A</b>
			<b>N/A</b>	Landing Slope (%)	<b>N/A</b>	<b>N/A</b>
			<b>N/A</b>	Landing X Slope (%)	<b>N/A</b>	<b>N/A</b>
			<b>N/A</b>	Landing Curb? (Y/N)	<b>N/A</b>	<b>N/A</b>
			<b>N/A</b>	Shared Landing?	<b>N/A</b>	
			<b>N/A</b>	Gutter Ponding?	<b>N/A</b>	<b>N/A</b>
			<b>N/A</b>	Gutter Lip Ht (in)	<b>N/A</b>	<b>N/A</b>
			<b>N/A</b>	Painted X Walk1?	<b>Yes</b>	<b>N/A</b>

X Walk 1 Direction	<b>To W</b>	
			<b>N/A</b>	X Walk 1 Width (in)	<b>88.0</b>	<b>N/A</b>
				X Walk 1 Slope (%)	<b>1.0</b>	
				X Walk 1 X Slope (%)	<b>1.7</b>	
			<b>N/A</b>	Ramp inside XWalk1?	<b>Yes</b>	<b>N/A</b>
<p>Surveyor Notes:</p> <p><b>N/A</b></p> <p>PROW/ADA:</p> <p><b>R304.2.2</b></p>			<b>N/A</b>	Road Slope (%)	<b>N/A</b>	<b>N/A</b>
			<b>N/A</b>	Road X Slope (%)	<b>N/A</b>	<b>N/A</b>
			<b>N/A</b>	Any Obstructions?	<b>N/A</b>	<b>N/A</b>
				Obstruction Type		
					<b>N/A</b>	<b>N/A</b>
			<b>Yes</b>	Surface Condition? (G/P)		<b>Good</b>
Total Cost:		\$ 1850.00
