## Access Compliance Report Public Rights-of-Way (Curb Ramps)

Intersection ID: 28638Main Street: RAU\_CTCross Street: STEWARTS\_CROSSING\_DRLocation:NEADA ID: 063985253FF6Ramp Type: PerpInitial Pass/Fail: FailOverall Compliance: NoSeverity Score: 8.75

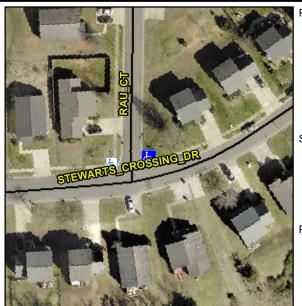
| ossible Solution | |
|---|---|
| Not Found, R304.5.1 | N/A |

| Field Measurements/Component Compliance | | | | | | |
|---|---|---|---|---|---|--|
| No | Ramp Width (in) | 47.0 | Yes | Ramp XSlope (%) | 1.5 | |

| ossible Solution | |
|---|---|
| Remove & Replace Entire Ramp. | N/A |
