## Access Compliance Report Public Rights-of-Way (Curb Ramps)

Intersection ID: 10040584Main Street: W\_ARROWOOD\_RDCross Street: N/ALocation:NWADA ID: 064AA6A86496Ramp Type: PerpInitial Pass/Fail: PassOverall Compliance: NoSeverity Score:0

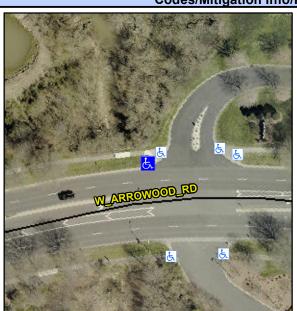
Field Measurements/Component Compilance								
Compl	iance Description	Data	Comp	liance Description	Data			
N/A	Ramp Length (in)	30.5	Yes	Ramp Slope (%)	8.0			
Yes	Ramp Width (in)	48.0	Yes	Ramp XSlope (%)	1.4			
N/A	Flare Type LT	Sloped	N/A	Flare Type RT	N/A			
N/A	Flare Slope LT (%)	5.0	Yes	Flare Slope RT (%)	2.4			
N/A	Flare Traversable LT?	No	N/A	Flare Traversable RT?	Yes			
No	Landing Length (in)	26.0	Yes	DWS Provided?	Yes			
Yes	Landing Width (in)	48.0	Yes	DWS Contrast?	Yes			
No	Landing Slope (%)	4.3	Yes	DWS Length (in)	24.0			
No	Landing X Slope (%)	3.3	Yes	DWS Full Width?	Yes			
N/A	Landing Curb? (Y/N)	No	No	DWS Offset (in)	3.0			
N/A	Shared Landing?	No						
Yes	Gutter Ponding?	No	Yes	Gutter Slope (%)	4.0			
Yes	Gutter Lip Ht (in)	0.0	Yes	Gutter X Slope (%)	0.6			
N/A	Painted X Walk1?	No	N/A	Painted X Walk2?	N/A			
	X Walk 1 Direction	To S		X Walk 2 Direction	N/A			
N/A	X Walk 1 Width (in)	N/A	N/A	X Walk 2 Width (in)	N/A

X Walk 1 Slope (%)	5.0		X Walk 2 Slope (%)	N/A			
	X Walk 1 X Slope (%)	0.9		X Walk 2 X Slope (%)	N/A			
N/A	Ramp inside XWalk1?	N/A	N/A	Ramp inside XWalk2?	N/A			
	Road Slope (%)	N/A	N/A	Clear Space?	Yes			
	Road X Slope (%)	N/A	N/A	Clear Space to XWalk (in)	N/A			
Yes	Any Obstructions?	No	Yes	Storm Grate/Utility Hazard?	No			
	Obstruction Type			Storm Grate/Utility Type				
		N/A			N/A			
			Yes	Surface Condition? (G/P)	Good

Possible Solutions:					
Remove & Replace Entire Ramp.					
Surveyor Notes:					
N/A					
PDOW/ADA					
PROW/ADA:					
R304.2.1, R304.2.2-Perp, R304.3.2- Para, R304.5.3, R305.2					
1 414, 11004.0.0, 11000.2
