Access Compliance Report

Public Rights-of-Way

(Curb Ramps)

Intersection ID: 48454	Main Street: RED_RUST_LN	Cross Street: GOLF_LINKS_DR	Location: NW
ADA ID: 06503A7BB43B	Ramp Type: Perp	Initial Pass/Fail: Fail	Overall Compliance: No
Severity Score: 12.5			
Codes/Mitigation Info/Possible Solution		Field Measurements/Component Compliance

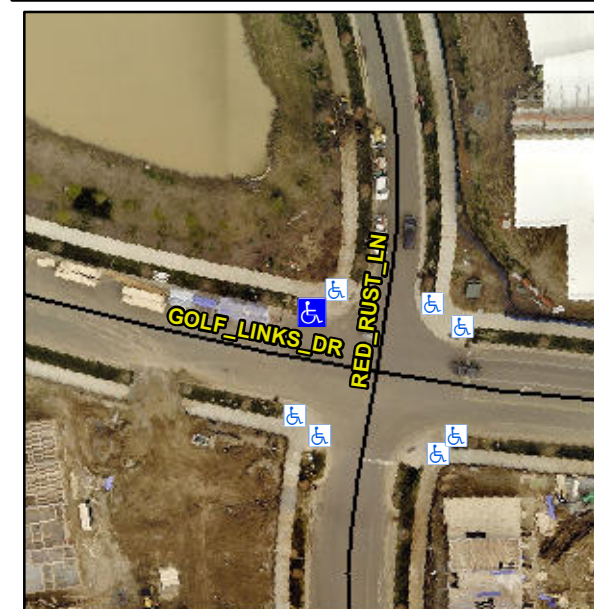
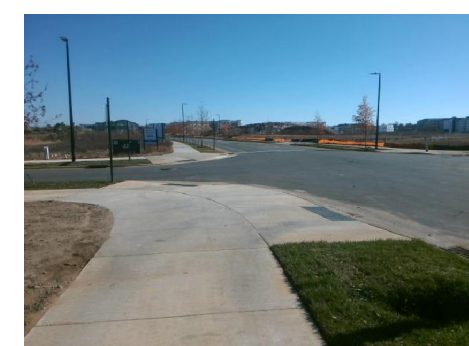
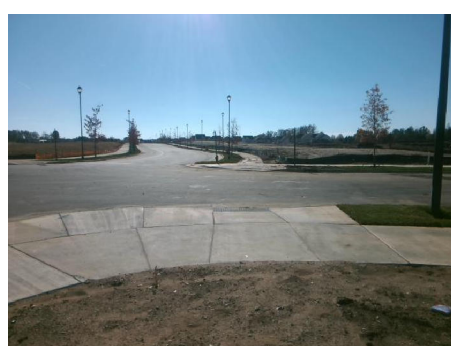
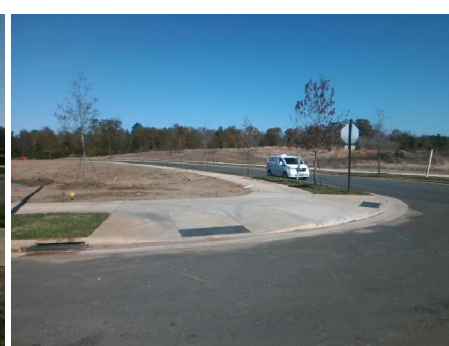
Not Found, R304.2.2

Compliance	Description	Data	Compliance	Description	Data
N/A	Ramp Length (in)	96.0	No	Ramp Slope (%)	8.9
Yes	Ramp Width (in)	60.0	Yes	Ramp XSlope (%)	1.0
N/A	Flare Type LT	N/A	N/A	Flare Type RT	N/A
N/A	Flare Slope LT (%)	N/A	N/A	Flare Slope RT (%)	N/A
N/A	Flare Traversable LT?	N/A	N/A	Flare Traversable RT?	N/A
N/A	Landing Length (in)	N/A	N/A	DWS Provided?	N/A
N/A	Landing Width (in)	N/A	N/A	DWS Contrast?	N/A
N/A	Landing Slope (%)	N/A	N/A	DWS Length (in)	N/A
N/A	Landing X Slope (%)	N/A	N/A	DWS Full Width?	N/A
N/A	Landing Curb? (Y/N)	N/A	N/A	DWS Offset (in)	N/A
N/A	Shared Landing?	N/A			
N/A	Gutter Ponding?	N/A	N/A	Gutter Slope (%)	N/A
N/A	Gutter Lip Ht (in)	N/A	N/A	Gutter X Slope (%)	N/A
N/A	Painted X Walk1?	No	N/A	Painted X Walk2?	N/A
	X Walk 1 Direction	To SW		X Walk 2 Direction	N/A
N/A	X Walk 1 Width (in)	N/A	N/A	X Walk 2 Width (in)	N/A
	X Walk 1 Slope (%)	3.5		X Walk 2 Slope (%)	N/A
	X Walk 1 X Slope (%)	0.8		X Walk 2 X Slope (%)	N/A

N/A	Ramp inside XWalk1?	N/A	N/A	Ramp inside XWalk2?	N/A
	Road Slope (%)	N/A	N/A	Clear Space?	N/A
	Road X Slope (%)	N/A	N/A	Clear Space to XWalk (in)	N/A
N/A	Any Obstructions?	N/A	N/A	Storm Grate/Utility Hazard?	N/A
	Obstruction Type			Storm Grate/Utility Type	
		N/A			N/A
			Yes	Surface Condition? (G/P)	Good

Remove & Replace Entire Ramp.

Total Cost: \$ 1850.00
