Access Compliance Report

Public Rights-of-Way

(Curb Ramps)

Intersection ID: 24499	Main Street: BECKMORE_PL	Cross Street: SAINTFIELD_PL	Location: SW
ADA ID: 065A1BD94F85	Ramp Type: Perp	Initial Pass/Fail: Fail	Overall Compliance: No
Severity Score: 1.25			
Codes/Mitigation Info/Possible Solution		Field Measurements/Component Compliance

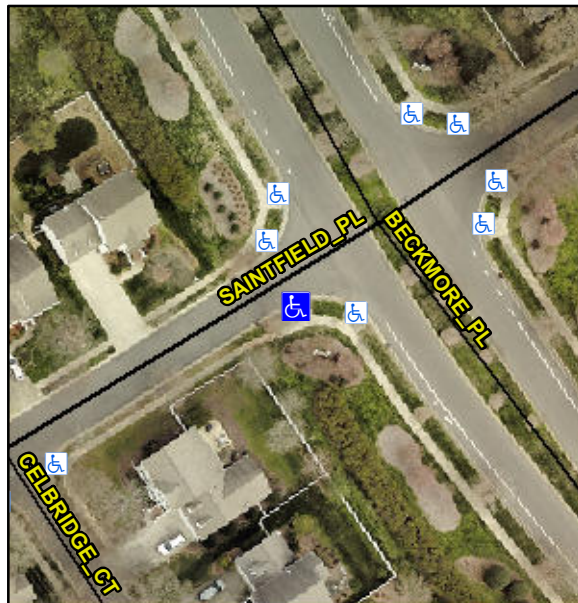
Not Found, R304.5.3

Compliance	Description	Data	Compliance	Description	Data
N/A	Ramp Length (in)	92.0	Yes	Ramp Slope (%)	7.3
Yes	Ramp Width (in)	48.0	No	Ramp XSlope (%)	2.4
N/A	Flare Type LT	N/A	N/A	Flare Type RT	N/A
N/A	Flare Slope LT (%)	N/A	N/A	Flare Slope RT (%)	N/A
N/A	Flare Traversable LT?	N/A	N/A	Flare Traversable RT?	N/A
N/A	Landing Length (in)	N/A	N/A	DWS Provided?	N/A
N/A	Landing Width (in)	N/A	N/A	DWS Contrast?	N/A
N/A	Landing Slope (%)	N/A	N/A	DWS Length (in)	N/A
N/A	Landing X Slope (%)	N/A	N/A	DWS Full Width?	N/A
N/A	Landing Curb? (Y/N)	N/A	N/A	DWS Offset (in)	N/A
N/A	Shared Landing?	N/A			
N/A	Gutter Ponding?	N/A	N/A	Gutter Slope (%)	N/A
N/A	Gutter Lip Ht (in)	N/A	N/A	Gutter X Slope (%)	N/A
N/A	Painted X Walk1?	No	N/A	Painted X Walk2?	N/A
	X Walk 1 Direction	To N		X Walk 2 Direction	N/A
N/A	X Walk 1 Width (in)	N/A	N/A	X Walk 2 Width (in)	N/A
	X Walk 1 Slope (%)	1.8		X Walk 2 Slope (%)	N/A
	X Walk 1 X Slope (%)	2.8		X Walk 2 X Slope (%)	N/A

N/A	Ramp inside XWalk1?	N/A	N/A	Ramp inside XWalk2?	N/A
	Road Slope (%)	N/A	N/A	Clear Space?	N/A
	Road X Slope (%)	N/A	N/A	Clear Space to XWalk (in)	N/A
N/A	Any Obstructions?	N/A	N/A	Storm Grate/Utility Hazard?	N/A
	Obstruction Type			Storm Grate/Utility Type	
		N/A			N/A
			Yes	Surface Condition? (G/P)	Good

Possible Solutions:

Remove & Replace Entire Ramp.
