Access Compliance Report

Public Rights-of-Way

(Curb Ramps)

Intersection ID: 27197	Main Street: BALLANTYNE_COMMONS_PY	Cross Street: CRESTWOOD_DR	Location: NW
ADA ID: 067A04CE7868	Ramp Type: Perp	Initial Pass/Fail: Fail	Overall Compliance: No
Severity Score: 33.75			
Codes/Mitigation Info/Possible Solution		Field Measurements/Component Compliance

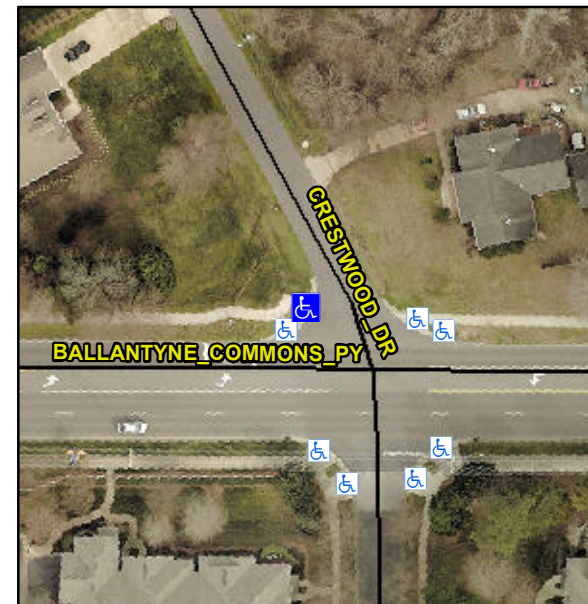
Compliance	Description	Data	Compliance	Description	Data
N/A	Ramp Length (in)	98.0	Yes	Ramp Slope (%)	4.3
No	Ramp Width (in)	47.0	No	Ramp XSlope (%)	9.1
N/A	Flare Type LT	N/A	N/A	Flare Type RT	N/A
N/A	Flare Slope LT (%)	N/A	N/A	Flare Slope RT (%)	N/A
N/A	Flare Traversable LT?	N/A	N/A	Flare Traversable RT?	N/A
N/A	Landing Length (in)	N/A	N/A	DWS Provided?	N/A
N/A	Landing Width (in)	N/A	N/A	DWS Contrast?	N/A
N/A	Landing Slope (%)	N/A	N/A	DWS Length (in)	N/A
N/A	Landing X Slope (%)	N/A	N/A	DWS Full Width?	N/A
N/A	Landing Curb? (Y/N)	N/A	N/A	DWS Offset (in)	N/A
N/A	Shared Landing?	N/A			
N/A	Gutter Ponding?	N/A	N/A	Gutter Slope (%)	N/A
N/A	Gutter Lip Ht (in)	N/A	N/A	Gutter X Slope (%)	N/A
N/A	Painted X Walk1?	No	N/A	Painted X Walk2?	N/A
	X Walk 1 Direction	To SE		X Walk 2 Direction	N/A
N/A	X Walk 1 Width (in)	N/A	N/A	X Walk 2 Width (in)	N/A
	X Walk 1 Slope (%)	5.7		X Walk 2 Slope (%)	N/A
	X Walk 1 X Slope (%)	9.7		X Walk 2 X Slope (%)	N/A

N/A	Ramp inside XWalk1?	N/A	N/A	Ramp inside XWalk2?	N/A
	Road Slope (%)	N/A	N/A	Clear Space?	N/A
	Road X Slope (%)	N/A	N/A	Clear Space to XWalk (in)	N/A
N/A	Any Obstructions?	N/A	N/A	Storm Grate/Utility Hazard?	N/A
	Obstruction Type			Storm Grate/Utility Type	
		N/A			N/A
			Yes	Surface Condition? (G/P)	Good

Possible Solutions:

Remove & Replace Entire Ramp.
