Access Compliance Report Public Rights-of-Way (Curb Ramps)

Intersection ID: 46197	Main Str	Cross Street: SEVEN_OAKS_DR					Location:	SW		
ADA ID: 06963585F7FB	Ramp Ty	Ramp Type: PerpDiag			Initial Pass/Fail: Fail Overall Compliance: No				22.5	
Codes/Mitigation Info/Possible Solution					Field Measurements/Component Compliance					
		Possible Solutions:					Data Compliance Description

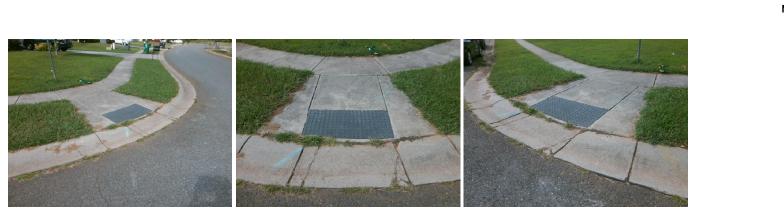
1.50 5.	Remove & Replace Curb Ramp V	Vith	N/A	Ramp Length (in)	73.5		Ramp Slope (%)	8.6	
		Two New Directional Ramps or	VICI I	No	Ramp Width (in)	46.5		Ramp XSlope (%)	2.3	
		Equivalent.		N/A	Flare Type LT	N/A	N/A	Flare Type RT	N/A	
100 A 10 100 100 100 100 100 100 100 100				N/A	Flare Slope LT (%)	N/A	N/A	Flare Slope RT (%)	N/A	
				N/A	Flare Traversable LT?	N/A		Flare Traversable RT?	N/A	
TEREALS				N/A	Landing Length (in)	N/A	N/A	DWS Provided?	N/A	
FEIGU				N/A	Landing Width (in)	N/A	N/A	DWS Contrast?	N/A

Yes Surface Condition? (G/P)

Good
