Access Compliance Report

Public Rights-of-Way

(Curb Ramps)

| Intersection ID: 50271 | Main Street: CLANTON_RD | Cross Street: SOUTH_BV | Location: SW |

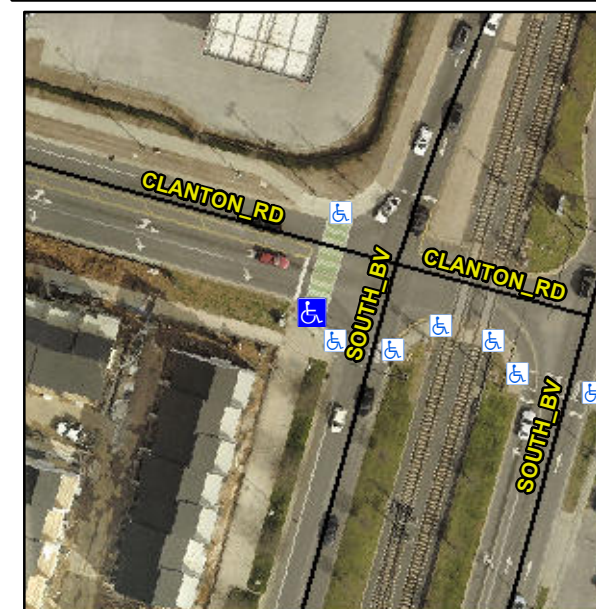
| ADA ID: 06B5F6B2E355 | Ramp Type: Perp | Initial Pass/Fail: Pass | Overall Compliance: No |
| Severity Score: 0.25 | | | |

R304.5.3

| Compliance | Description | Data | Compliance | Description | Data |
|---|---|---|---|---|---|
| Yes | Ramp Width (in) | 72.0 | No | Ramp XSlope (%) | 3.3 |

Possible Solutions:

Remove & Replace Entire Ramp.

Total Cost: \$ 1850.00
