Access Compliance Report

Public Rights-of-Way

(Curb Ramps)

Intersection ID: 5588	Main Street: CARVER_BV	Cross Street: ROCKWELL_BV	Location: NE
ADA ID: 06B9FA0A23D7	Ramp Type: Para	Initial Pass/Fail: Fail	Overall Compliance: No
Codes/Mitigation Info/Possible Solution			Severity Score: 25
			Field Measurements/Component Compliance

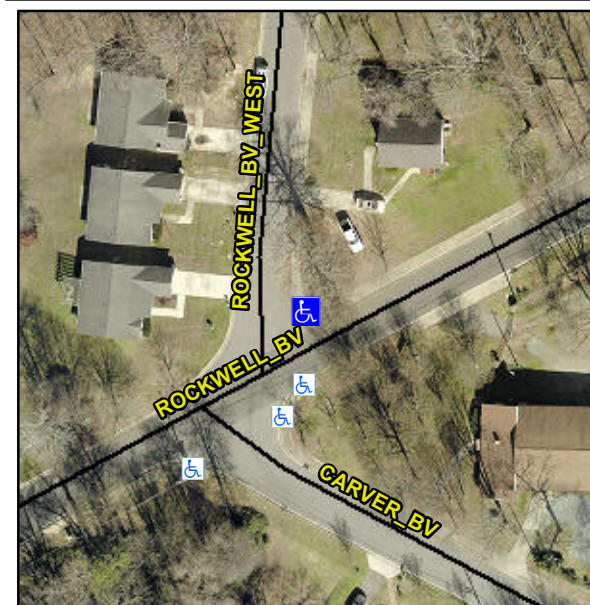
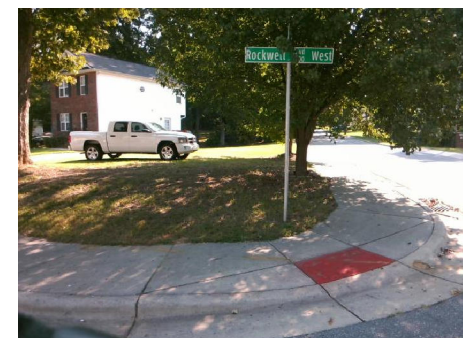
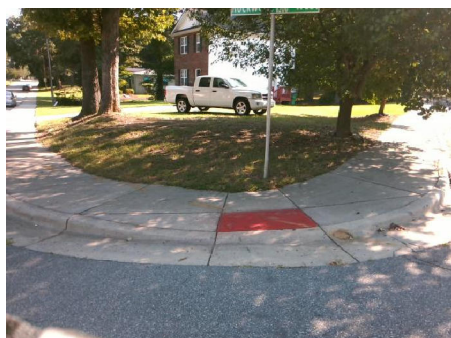
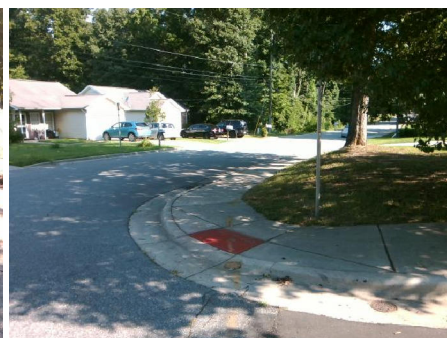
R304.5.1, R304.3.2

Compliance	Description	Data	Compliance	Description	Data
N/A	Ramp Length LT (in)	N/A	N/A	Ramp Length RT (in)	44.0
N/A	Ramp Width LT (in)	N/A	No	Ramp Width RT (in)	36.0
N/A	Ramp Slope LT (%)	N/A	No	Ramp Slope RT (%)	14.7
N/A	Ramp XSlope LT (%)	N/A	Yes	Ramp XSlope RT (%)	1.6
N/A	Landing Length (in)	N/A	N/A	DWS Provided?	N/A
N/A	Landing Width (in)	N/A	N/A	DWS Contrast?	N/A
N/A	Landing Slope (%)	N/A	N/A	DWS Length (in)	N/A
N/A	Landing X Slope (%)	N/A	N/A	DWS Full Width?	N/A
N/A	Landing Curb? (Y/N)	N/A	N/A	DWS Offset (in)	N/A
N/A	Shared Landing?	N/A			
N/A	Gutter Ponding?	N/A	N/A	Gutter Slope (%)	N/A
N/A	Gutter Lip Ht (in)	N/A	N/A	Gutter X Slope (%)	N/A
N/A	Painted X Walk1?	No	N/A	Painted X Walk2?	N/A
	X Walk 1 Direction	To S		X Walk 2 Direction	N/A
N/A	X Walk 1 Width (in)	N/A	N/A	X Walk 2 Width (in)	N/A
	X Walk 1 Slope (%)	2.0		X Walk 2 Slope (%)	N/A
	X Walk 1 X Slope (%)	2.6		X Walk 2 X Slope (%)	N/A
N/A	Ramp inside XWalk1?	N/A	N/A	Ramp inside XWalk2?	N/A

Road Slope (%)	N/A	N/A	Clear Space?	N/A
	Road X Slope (%)	N/A	N/A	Clear Space to XWalk (in)	N/A
N/A	Any Obstructions?	N/A	N/A	Storm Grate/Utility Hazard?	N/A
	Obstruction Type			Storm Grate/Utility Type	
		N/A			N/A
			Yes	Surface Condition? (G/P)	Good
			N/A	Curb Slope (%)	15.5

Remove & Replace Entire Ramp.
