Access Compliance Report

Public Rights-of-Way

(Curb Ramps)

Intersection ID: 14552	Main Street: BAXTER_ST	Cross Street: AVANT_ST	Location: NE
ADA ID: 06BC193B254E	Ramp Type: PerpDiag	Initial Pass/Fail: Fail	Overall Compliance: No
		Severity Score: 12.5

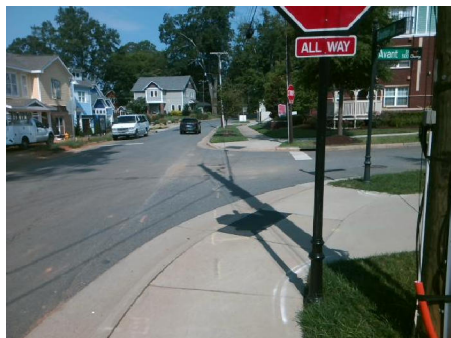
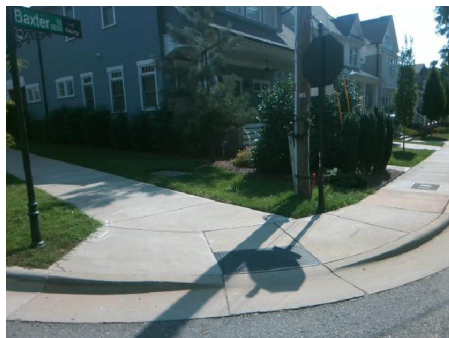
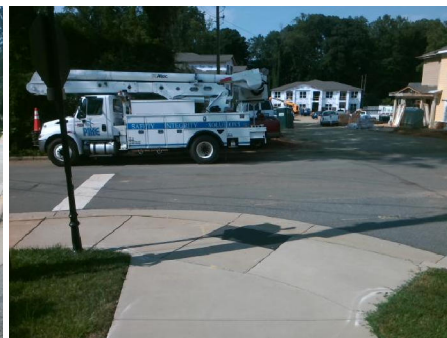
Compliance	Description	Data	Compliance	Description	Data
N/A	Ramp Length (in)	59.0	Yes	Ramp Slope (%)	5.1
Yes	Ramp Width (in)	48.0	No	Ramp XSlope (%)	6.4
N/A	Flare Type LT	N/A	N/A	Flare Type RT	N/A
N/A	Flare Slope LT (%)	N/A	N/A	Flare Slope RT (%)	N/A
N/A	Flare Traversable LT?	N/A	N/A	Flare Traversable RT?	N/A
N/A	Landing Length (in)	N/A	N/A	DWS Provided?	N/A
N/A	Landing Width (in)	N/A	N/A	DWS Contrast?	N/A
N/A	Landing Slope (%)	N/A	N/A	DWS Length (in)	N/A
N/A	Landing X Slope (%)	N/A	N/A	DWS Full Width?	N/A
N/A	Landing Curb? (Y/N)	N/A	N/A	DWS Offset (in)	N/A
N/A	Shared Landing?	N/A			
N/A	Gutter Ponding?	N/A	N/A	Gutter Slope (%)	N/A
N/A	Gutter Lip Ht (in)	N/A	N/A	Gutter X Slope (%)	N/A
N/A	Painted X Walk1?	No	N/A	Painted X Walk2?	No
	X Walk 1 Direction	To NW		X Walk 2 Direction	To SW
N/A	X Walk 1 Width (in)	N/A	N/A	X Walk 2 Width (in)	N/A
	X Walk 1 Slope (%)	0.5		X Walk 2 Slope (%)	1.1
	X Walk 1 X Slope (%)	6.1		X Walk 2 X Slope (%)	1.4

N/A	Ramp inside XWalk1?	N/A	N/A	Ramp inside XWalk2?	N/A
	Road Slope (%)	4.5	N/A	Clear Space?	N/A
	Road X Slope (%)	5.9	N/A	Clear Space to XWalk (in)	N/A
N/A	Any Obstructions?	N/A	N/A	Storm Grate/Utility Hazard?	N/A
	Obstruction Type			Storm Grate/Utility Type	
		N/A			N/A
			Yes	Surface Condition? (G/P)	Good

Remove & Replace Curb Ramp With Two New Directional Ramps or Equivalent.
