## **Access Compliance Report Public Rights-of-Way** (Curb Ramps)

Intersection ID: 29429 Main Street: BRADSTREET COMMONS WYCross Street: DELUCA DR Location: ADA ID: 06C5F56215BB Ramp Type: Combination2 Initial Pass/Fail: Fail **Overall Compliance: No Severity Score:** 22.5

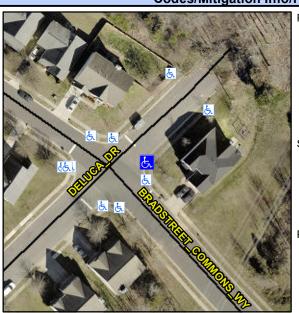
Possible Solutions: Remove & Replace Entire Ramp. Surveyor Notes: LT RP < 5% PROW/ADA: Not Found, R304.5.1, R304.5.3, R304.3.2

| Comp | liance Description | Data | Comp | liance Description | Data |
|---|---|---|---|---|---|
| N/A | Ramp Slope LT (%) | 3.0 | No | Ramp Slope RT (%) | 8.9 |
| N/A | Ramp XSlope LT (%) | 4.0 | No | Ramp XSlope RT (%) | 2.5 |
| No | Ramp Width (in) | 46.5 | No | Ramp XSlope (%) | 3.3 |
