# Access Compliance Report

## Public Rights-of-Way

### (Curb Ramps)

Intersection ID: 13639	Main Street: BRIAR_CREEK_RD	Cross Street: CENTRAL_AV	Location: NE
ADA ID: 06D266EDCD7A	Ramp Type: Perp	Initial Pass/Fail: Fail	Overall Compliance: No
Severity Score: 21.25			
Codes/Mitigation Info/Possible Solution		Field Measurements/Component Compliance

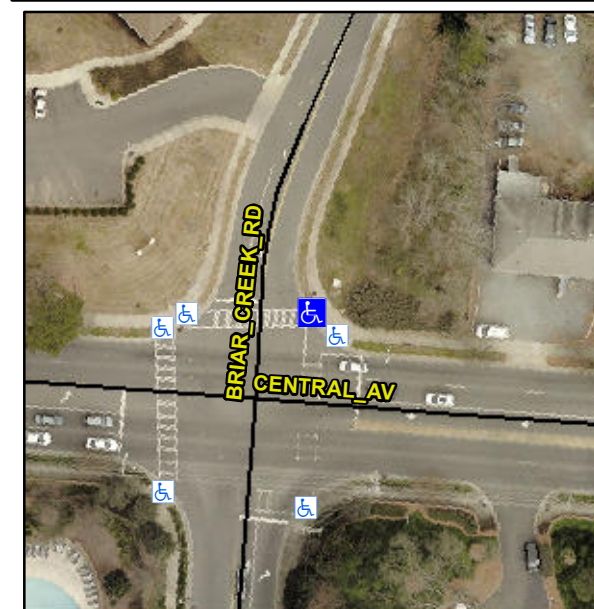
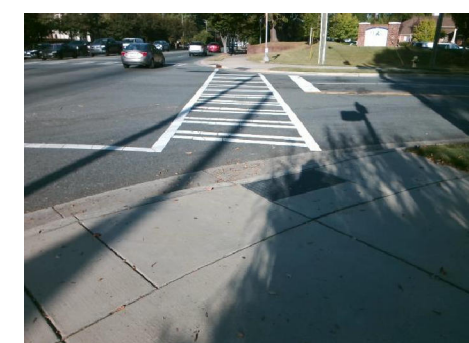
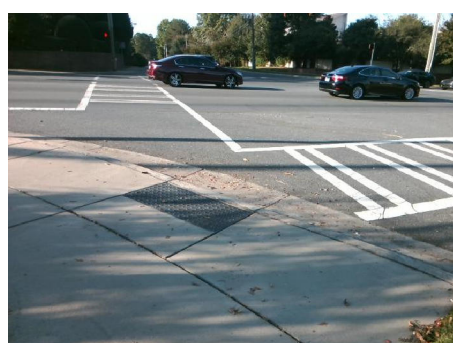
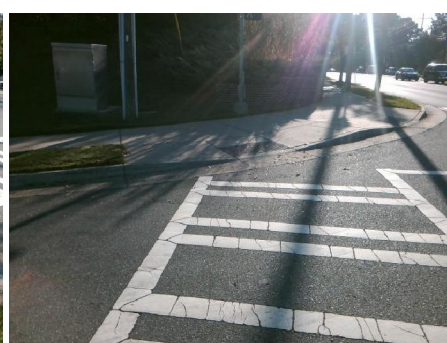
**Not Found, R304.5.1, R304.5.3**

Compliance	Description	Data	Compliance	Description	Data
N/A	Ramp Length (in)	48.5	Yes	Ramp Slope (%)	6.3
No	Ramp Width (in)	46.5	No	Ramp XSlope (%)	6.3
N/A	Flare Type LT	N/A	N/A	Flare Type RT	N/A
N/A	Flare Slope LT (%)	N/A	N/A	Flare Slope RT (%)	N/A
N/A	Flare Traversable LT?	N/A	N/A	Flare Traversable RT?	N/A
N/A	Landing Length (in)	N/A	N/A	DWS Provided?	N/A
N/A	Landing Width (in)	N/A	N/A	DWS Contrast?	N/A
N/A	Landing Slope (%)	N/A	N/A	DWS Length (in)	N/A
N/A	Landing X Slope (%)	N/A	N/A	DWS Full Width?	N/A
N/A	Landing Curb? (Y/N)	N/A	N/A	DWS Offset (in)	N/A
N/A	Shared Landing?	N/A			
N/A	Gutter Ponding?	N/A	N/A	Gutter Slope (%)	N/A
N/A	Gutter Lip Ht (in)	N/A	N/A	Gutter X Slope (%)	N/A
N/A	Painted X Walk1?	Yes	N/A	Painted X Walk2?	N/A
	X Walk 1 Direction	To W		X Walk 2 Direction	N/A
N/A	X Walk 1 Width (in)	100.0	N/A	X Walk 2 Width (in)	N/A
	X Walk 1 Slope (%)	1.4		X Walk 2 Slope (%)	N/A
	X Walk 1 X Slope (%)	5.7		X Walk 2 X Slope (%)	N/A

N/A	Ramp inside XWalk1?	Yes	N/A	Ramp inside XWalk2?	N/A
	Road Slope (%)	N/A	N/A	Clear Space?	N/A
	Road X Slope (%)	N/A	N/A	Clear Space to XWalk (in)	N/A
N/A	Any Obstructions?	N/A	N/A	Storm Grate/Utility Hazard?	N/A
	Obstruction Type			Storm Grate/Utility Type	
		N/A			N/A
		Yes		Surface Condition? (G/P)	Good

**Remove & Replace Entire Ramp.**

Total Cost: \$ 1850.00
