# Access Compliance Report

## Public Rights-of-Way

| Intersection ID: 51045 | Main Street: PALATINE_LN | Cross Street: KENDALL_DR | Location: NW |
| ADA ID: 06E6637E61D4 | Ramp Type: PerpDiag | Initial Pass/Fail: Fail | Overall Compliance: No |

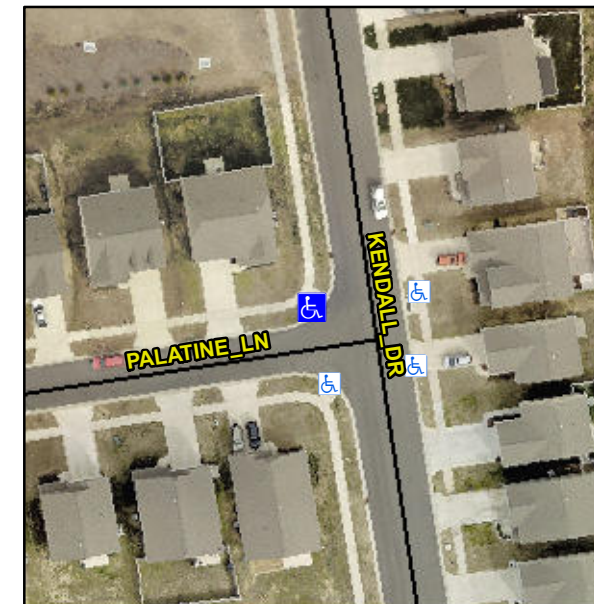
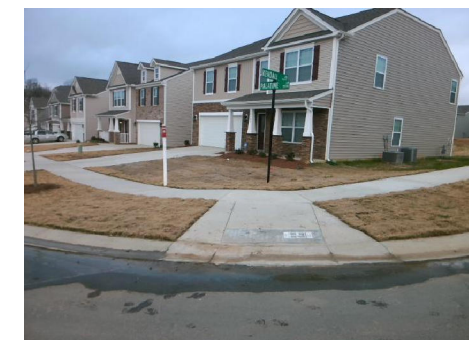
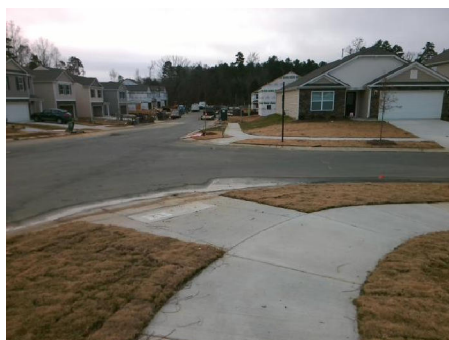
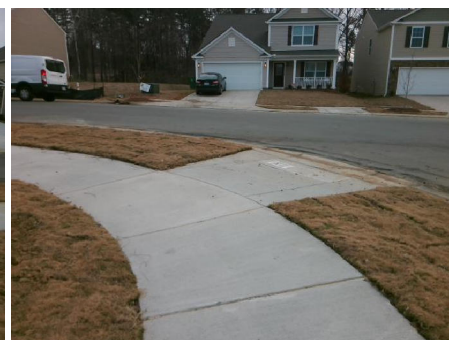
| | | | Severity Score: 13.75 |

| Compliance | Description | Data | Compliance | Description | Data |
|---|---|---|---|---|---|
| N/A | Ramp Length (in) | 94.0 | No | Ramp Slope (%) | 8.4 |
| Yes | Ramp Width (in) | 61.0 | No | Ramp XSlope (%) | 3.8 |

**Remove & Replace Curb Ramp With Two New Directional Ramps or Equivalent.**

**R304.2.2, R304.5.3**
