Access Compliance Report

Public Rights-of-Way

(Curb Ramps)

| Intersection ID: 53515 | Main Street: STONEWELLS_DR | Cross Street: GLENBURN_LN | Location: | N |

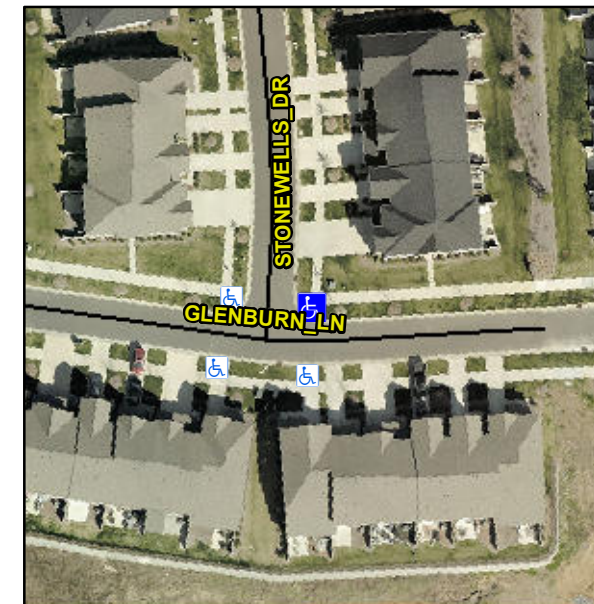
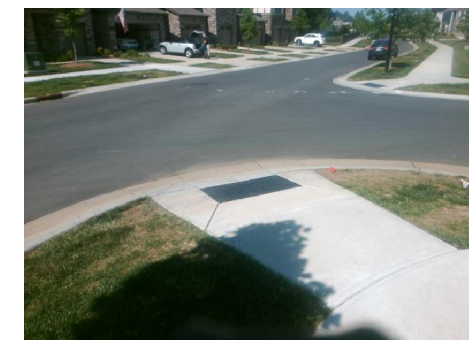
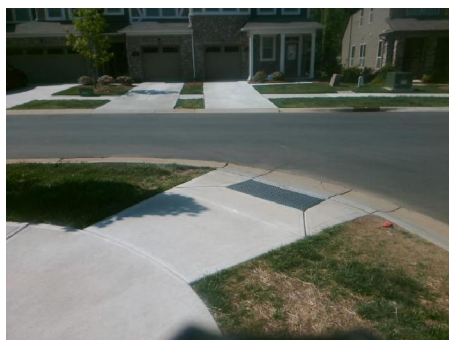
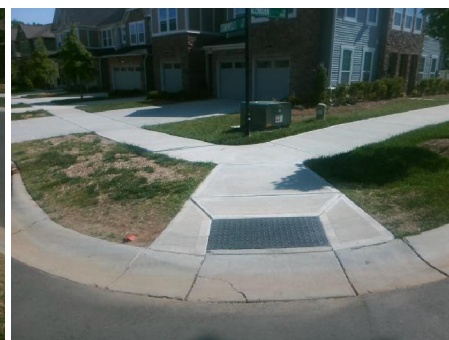
| ADA ID: 06EC776A4ED4 | Ramp Type: PerpDiag | Initial Pass/Fail: Fail | Overall Compliance: No | Severity Score: 25 |

Not Found, R304.2.2, R304.5.3

| Compliance | Description | Data | Compliance | Description | Data |
|---|---|---|---|---|---|
| N/A | Ramp Length (in) | 105.0 | No | Ramp Slope (%) | 10.6 |
| Yes | Ramp Width (in) | 48.0 | No | Ramp XSlope (%) | 6.3 |

Remove & Replace Curb Ramp With Two New Directional Ramps or Equivalent.
