Access Compliance Report Public Rights-of-Way (Curb Ramps)

Intersection ID: 2754	ion ID: 2754 Main Street: KINGLET LN Cross Stree					treet: WINGMONT DR			N
								Location:	
ADA ID: 06ECA3107A86 Ramp Type: PerpDiag			Initial F	Initial Pass/Fail: Fail Overall Compliance: No				o Severity Score:	26.25
Codes/Mitigation Info/Possible Solution				Field Measurements/Component Compliance					
	A REAL PROPERTY OF THE PROPERT	Possible Solutions:		Compliance Description Data C			Comp	Compliance Description	
		Remove & Replace Curb Ramp	With	N/A	Ramp Length (in)	49.0	No	Ramp Slope (%)	12.1
		Two New Directional Ramps or		Yes	Ramp Width (in)	98.0	No	Ramp XSlope (%)	2.1
		Equivalent.		N/A	Flare Type LT	N/A	N/A	Flare Type RT	N/A
				N/A	Flare Slope LT (%)	N/A	N/A	Flare Slope RT (%)	N/A
				N/A	Flare Traversable LT?	N/A	N/A	Flare Traversable RT?	N/A
				N/A	Landing Length (in)	N/A	N/A	DWS Provided?	N/A
		Surveyor Notes:		N/A	Landing Width (in)	N/A	N/A	DWS Contrast?	N/A
		N/A		N/A	Landing Slope (%)	N/A	N/A	DWS Length (in)	N/A

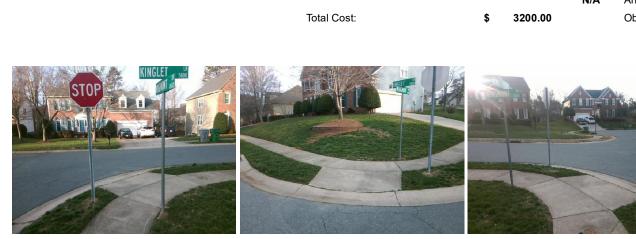
(m. a. 19. b. //				N/A	Landing X Slope (%)	N/A	N/A	DWS Full Width?	N/A
t.				N/A	Landing Curb? (Y/N)	N/A	N/A	DWS Offset (in)	N/A
the second second				N/A	Shared Landing?	N/A			
		PROW/ADA:		N/A	Gutter Ponding?	N/A	N/A	Gutter Slope (%)	N/A
		Not Found, R304.2.2, R304.5.3		N/A	Gutter Lip Ht (in)	N/A	N/A	Gutter X Slope (%)	N/A
The second second	1 Rolling			N/A	Painted X Walk1?	No	N/A	Painted X Walk2?	No
					X Walk 1 Direction	To SW		X Walk 2 Direction	To SE
				N/A	X Walk 1 Width (in)	N/A	N/A	X Walk 2 Width (in)	N/A
Street 1 Name	KINGLET LN				X Walk 1 Slope (%)	0.2		X Walk 2 Slope (%)	0.0
Stop Condition-Street 2	None				X Walk 1 X Slope (%)	0.9		X Walk 2 X Slope (%)	1.6
Street 2 Name	WNGMONT DR			N/A	Ramp inside XWalk1?	N/A	N/A	Ramp inside XWalk2?	N/A
Stop Condition-Street 1	StopSign				Road Slope (%)	0.7	N/A	Clear Space?	N/A
					Road X Slope (%)	0.2	N/A	Clear Space to XWalk (in)	N/A
				N/A	Any Obstructions?	N/A	N/A	Storm Grate/Utility Hazard?	N/A

Yes Surface Condition? (G/P)

Good

Total Cost: \$	3200.00		Obstruction Type			Storm Grate/Utility Type	
						N/A			N/A
