Access Compliance Report

Public Rights-of-Way

(Curb Ramps)

Intersection ID: 28976	Main Street: BANNINGTON_RD	Cross Street: CARMEL_COMMONS_BV	Location: SE
ADA ID: 0701EFF3348D	Ramp Type: PerpDiag	Initial Pass/Fail: Fail	Overall Compliance: No
Codes/Mitigation Info/Possible Solution		Field Measurements/Component Compliance

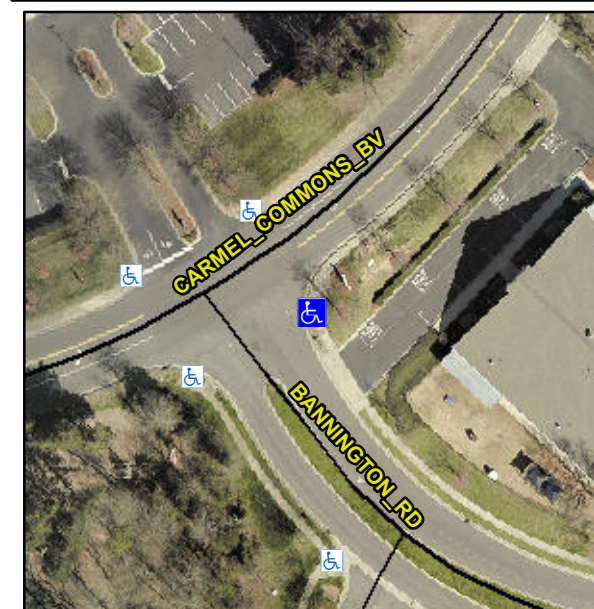
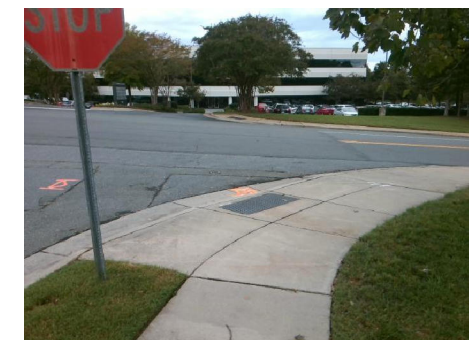
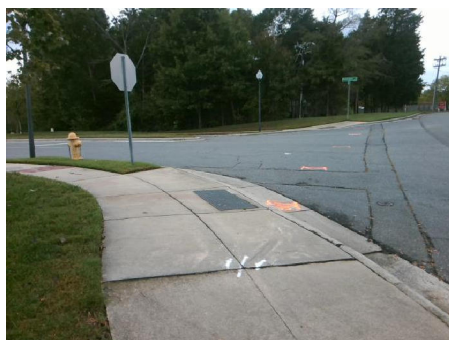
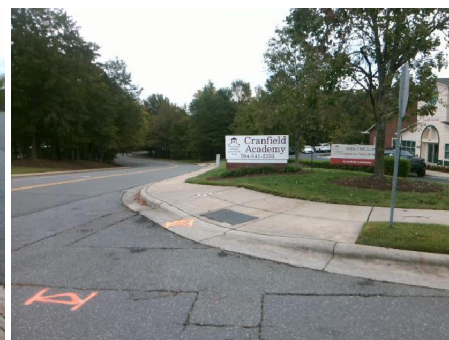
Not Found, R304.5.1, R304.5.3

Compliance	Description	Data	Compliance	Description	Data
N/A	Ramp Length (in)	95.0	Yes	Ramp Slope (%)	7.4
No	Ramp Width (in)	45.0	No	Ramp XSlope (%)	4.4
N/A	Flare Type LT	N/A	N/A	Flare Type RT	N/A
N/A	Flare Slope LT (%)	N/A	N/A	Flare Slope RT (%)	N/A
N/A	Flare Traversable LT?	N/A	N/A	Flare Traversable RT?	N/A
N/A	Landing Length (in)	N/A	N/A	DWS Provided?	N/A
N/A	Landing Width (in)	N/A	N/A	DWS Contrast?	N/A
N/A	Landing Slope (%)	N/A	N/A	DWS Length (in)	N/A
N/A	Landing X Slope (%)	N/A	N/A	DWS Full Width?	N/A
N/A	Landing Curb? (Y/N)	N/A	N/A	DWS Offset (in)	N/A
N/A	Shared Landing?	N/A			
N/A	Gutter Ponding?	N/A	N/A	Gutter Slope (%)	N/A
N/A	Gutter Lip Ht (in)	N/A	N/A	Gutter X Slope (%)	N/A
N/A	Painted X Walk1?	No	N/A	Painted X Walk2?	No
	X Walk 1 Direction	To N		X Walk 2 Direction	To W
N/A	X Walk 1 Width (in)	N/A	N/A	X Walk 2 Width (in)	N/A
	X Walk 1 Slope (%)	0.3		X Walk 2 Slope (%)	3.9
	X Walk 1 X Slope (%)	4.5		X Walk 2 X Slope (%)	3.9

N/A	Ramp inside XWalk1?	N/A	N/A	Ramp inside XWalk2?	N/A
	Road Slope (%)	3.8	N/A	Clear Space?	N/A
	Road X Slope (%)	2.0	N/A	Clear Space to XWalk (in)	N/A
N/A	Any Obstructions?	N/A	N/A	Storm Grate/Utility Hazard?	N/A
	Obstruction Type			Storm Grate/Utility Type	
		N/A			N/A
			Yes	Surface Condition? (G/P)	Good

Remove & Replace Curb Ramp With Two New Directional Ramps or Equivalent.
