# Access Compliance Report

## Public Rights-of-Way

### (Curb Ramps)

| Intersection ID: 50340 | Main Street: KILSYTH_ST | Cross Street: CASTLECOVE_RD | Location: NE |

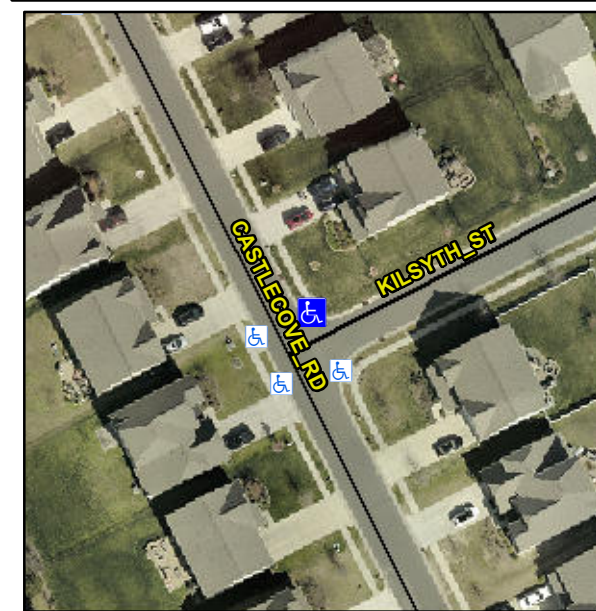
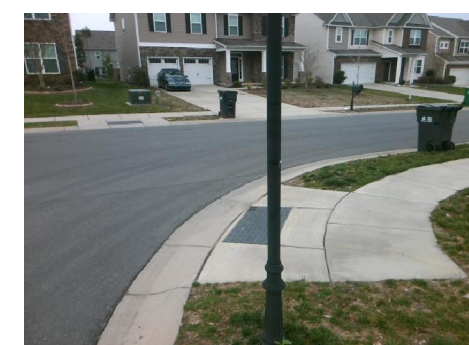
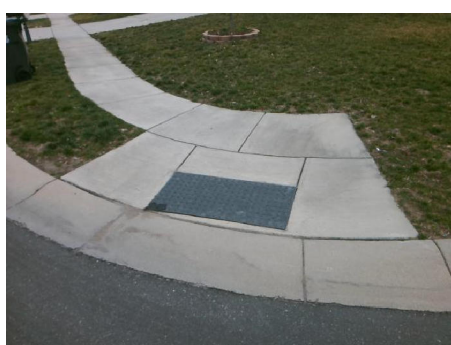
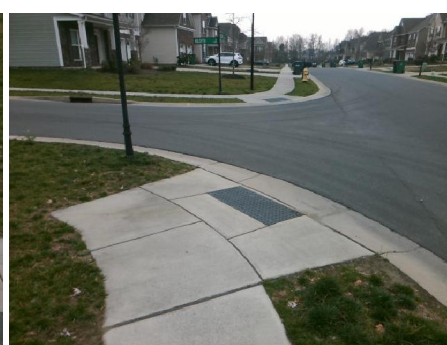
**R304.5.3, R304.2.2-Perp, R304.3.2-Para**

| Compliance | Description | Data | Compliance | Description | Data |
|---|---|---|---|---|---|
| Yes | Ramp Width (in) | 48.0 | No | Ramp XSlope (%) | 2.7 |
| No | Landing Slope (%) | 4.7 | Yes | DWS Length (in) | 24.0 |
| No | Landing X Slope (%) | 4.9 | Yes | DWS Full Width? | Yes |
| Yes | Gutter Lip Ht (in) | 0.0 | No | Gutter X Slope (%) | 2.8 |

**Remove & Replace Curb Ramp With Two New Directional Ramps or Equivalent. Remove & Replace Gutter.**
