Access Compliance Report Public Rights-of-Way (Curb Ramps)

Intersection ID: 27865Main Street: ALEXANDER_MILL_DRCross Street: MCCOMB_MANOR_CTLocation:SWADA ID: 07085B7D8A05Ramp Type: PerpInitial Pass/Fail: FailOverall Compliance: NoSeverity Score:25

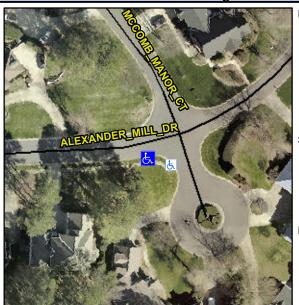
Field Measurements/Component Compliance									
Compliance Description		Data	Comp	oliance	Description	Data			
N/A	Ramp Length (in)	52.0	No	Ramp	Slope (%)	9.1			
Yes	Ramp Width (in)	48.0	No	Ramp	XSlope (%)	5.9			
N/A	Flare Type LT	N/A	N/A	Flare	Type RT	N/A			
N/A	Flare Slope LT (%)	N/A	N/A	Flare	Slope RT (%)	N/A			
N/A	Flare Traversable LT?	N/A	N/A	Flare	Traversable RT?	N/A			
N/A	Landing Length (in)	N/A	N/A	DWS	Provided?	N/A			
N/A	Landing Width (in)	N/A	N/A	DWS	Contrast?	N/A			
N/A	Landing Slope (%)	N/A	N/A	DWS	Length (in)	N/A			
N/A	Landing X Slope (%)	N/A	N/A	DWS	Full Width?	N/A			
N/A	Landing Curb? (Y/N)	N/A	N/A	DWS	Offset (in)	N/A			
N/A	Shared Landing?	N/A							
N/A	Gutter Ponding?	N/A	N/A	Gutter	Slope (%)	N/A			
N/A	Gutter Lip Ht (in)	N/A	N/A	Gutter	X Slope (%)	N/A			
N/A	Painted X Walk1?	No	N/A	Painte	ed X Walk2?	N/A			
	X Walk 1 Direction	To N		X Wal	k 2 Direction	N/A			
N/A	X Walk 1 Width (in)	N/A	N/A	X Wal	k 2 Width (in)	N/A

X Walk 1 Slope (%)	4.4		X Wal	k 2 Slope (%)	N/A			
	X Walk 1 X Slope (%)	3.4		X Wal	k 2 X Slope (%)	N/A			
N/A	Ramp inside XWalk1?	N/A	N/A	Ramp	inside XWalk2?	N/A			
	Road Slope (%)	N/A	N/A	Clear	Space?	N/A			
	Road X Slope (%)	N/A	N/A	Clear	Space to XWalk (in)	N/A			
N/A	Any Obstructions?	N/A	N/A	Storm	Grate/Utility Hazard?	N/A			
	Obstruction Type			Storm	Grate/Utility Type				
		N/A				N/A			
			Yes	Surfac	ce Condition? (G/P)	Good

"	1 033ibic Odiation	
1	Possible Solutions:	<u>c</u>
1	Remove & Replace Entire Ramp.	N
3		Υ
		N
		N
ú		N
Š		N
2	Surveyor Notes:	N
Ž	N/A	N
8		N
`		N
		N
	PROW/ADA:	N
1	Not Found, R304.2.2, R304.5.3	N
ļ		N
Š		
æ		N
		N
