Access Compliance Report

Public Rights-of-Way

(Curb Ramps)

Intersection ID: 13362	Main Street: BARRINGER_DR	Cross Street: WEST_BV	Location: NW
ADA ID: 07120D1F87EE	Ramp Type: PerpDiag	Initial Pass/Fail: Fail	Overall Compliance: No
Codes/Mitigation Info/Possible Solution		Field Measurements/Component Compliance

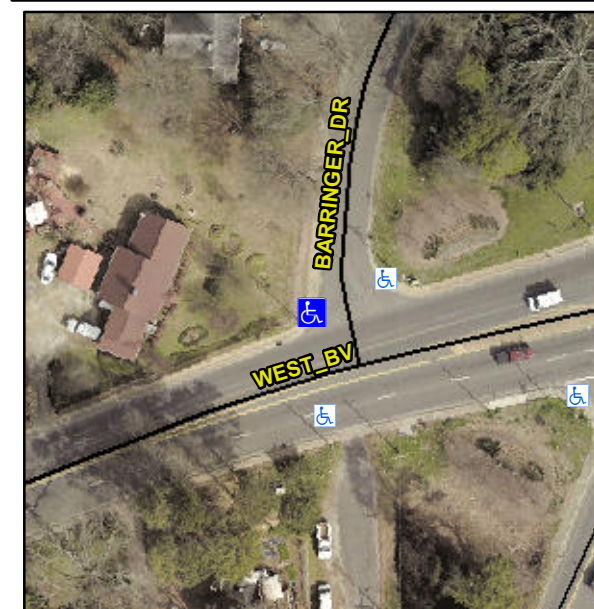
Not Found, R304.5.1, R304.2.2, R304.5.3

Compliance	Description	Data	Compliance	Description	Data
N/A	Ramp Length (in)	47.0	No	Ramp Slope (%)	15.0
No	Ramp Width (in)	39.0	No	Ramp XSlope (%)	5.1
N/A	Flare Type LT	N/A	N/A	Flare Type RT	N/A
N/A	Flare Slope LT (%)	N/A	N/A	Flare Slope RT (%)	N/A
N/A	Flare Traversable LT?	N/A	N/A	Flare Traversable RT?	N/A
N/A	Landing Length (in)	N/A	N/A	DWS Provided?	N/A
N/A	Landing Width (in)	N/A	N/A	DWS Contrast?	N/A
N/A	Landing Slope (%)	N/A	N/A	DWS Length (in)	N/A
N/A	Landing X Slope (%)	N/A	N/A	DWS Full Width?	N/A
N/A	Landing Curb? (Y/N)	N/A	N/A	DWS Offset (in)	N/A
N/A	Shared Landing?	N/A			
N/A	Gutter Ponding?	Yes	N/A	Gutter Slope (%)	N/A
N/A	Gutter Lip Ht (in)	N/A	N/A	Gutter X Slope (%)	N/A
N/A	Painted X Walk1?	No	N/A	Painted X Walk2?	No
	X Walk 1 Direction	To S		X Walk 2 Direction	To E
N/A	X Walk 1 Width (in)	N/A	N/A	X Walk 2 Width (in)	N/A
	X Walk 1 Slope (%)	1.0		X Walk 2 Slope (%)	3.4
	X Walk 1 X Slope (%)	5.5		X Walk 2 X Slope (%)	0.8

N/A	Ramp inside XWalk1?	N/A	N/A	Ramp inside XWalk2?	N/A
	Road Slope (%)	1.6	N/A	Clear Space?	N/A
	Road X Slope (%)	4.1	N/A	Clear Space to XWalk (in)	N/A
N/A	Any Obstructions?	N/A	N/A	Storm Grate/Utility Hazard?	N/A
	Obstruction Type			Storm Grate/Utility Type	
		N/A			N/A
		Yes		Surface Condition? (G/P)	Good

Possible Solutions:

Remove & Replace Curb Ramp With Two New Directional Ramps or Equivalent.
