Access Compliance Report

Public Rights-of-Way

(Curb Ramps)

Intersection ID: N/A	Main Street: TRAILMOOR_RD	Cross Street: BRECKFIELD_CT	Location: SE
ADA ID: 0715A995EC5B	Ramp Type: PerpDiag	Initial Pass/Fail: Fail	Overall Compliance: No
Severity Score: 12.5			
Codes/Mitigation Info/Possible Solution		Field Measurements/Component Compliance

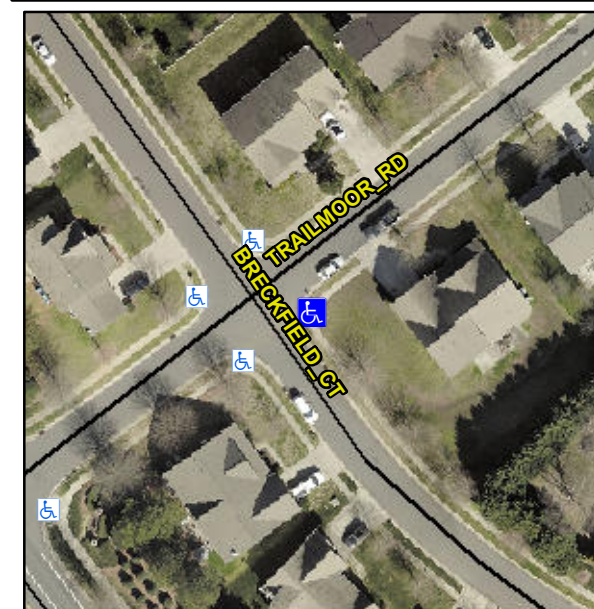
Compliance	Description	Data	Compliance	Description	Data
N/A	Ramp Length (in)	48.0	No	Ramp Slope (%)	8.8
Yes	Ramp Width (in)	48.0	Yes	Ramp XSlope (%)	1.1
N/A	Flare Type LT	N/A	N/A	Flare Type RT	N/A
N/A	Flare Slope LT (%)	N/A	N/A	Flare Slope RT (%)	N/A
N/A	Flare Traversable LT?	N/A	N/A	Flare Traversable RT?	N/A
N/A	Landing Length (in)	N/A	N/A	DWS Provided?	N/A
N/A	Landing Width (in)	N/A	N/A	DWS Contrast?	N/A
N/A	Landing Slope (%)	N/A	N/A	DWS Length (in)	N/A
N/A	Landing X Slope (%)	N/A	N/A	DWS Full Width?	N/A
N/A	Landing Curb? (Y/N)	N/A	N/A	DWS Offset (in)	N/A
N/A	Shared Landing?	N/A			
N/A	Gutter Ponding?	N/A	N/A	Gutter Slope (%)	N/A
N/A	Gutter Lip Ht (in)	N/A	N/A	Gutter X Slope (%)	N/A
N/A	Painted X Walk1?	No	N/A	Painted X Walk2?	No
	X Walk 1 Direction	To NW		X Walk 2 Direction	To SW
N/A	X Walk 1 Width (in)	N/A	N/A	X Walk 2 Width (in)	N/A
	X Walk 1 Slope (%)	1.0		X Walk 2 Slope (%)	0.5
	X Walk 1 X Slope (%)	2.2		X Walk 2 X Slope (%)	0.6

N/A	Ramp inside XWalk1?	N/A	N/A	Ramp inside XWalk2?	N/A
	Road Slope (%)	1.3	N/A	Clear Space?	N/A
	Road X Slope (%)	1.0	N/A	Clear Space to XWalk (in)	N/A
N/A	Any Obstructions?	N/A	N/A	Storm Grate/Utility Hazard?	N/A
	Obstruction Type			Storm Grate/Utility Type	
		N/A			N/A
			Yes	Surface Condition? (G/P)	Good

Possible Solutions:

Remove & Replace Curb Ramp With Two New Directional Ramps or Equivalent.

R304.2.2
