Intersection ID: 12605		Main Street: KENSINGTON_DR		Cross Street: THE_PLAZA		Location:		NW							
ADA ID: 0727E00F8C03		Ramp Type: Perp		Initial Pass/Fail: Fail		Overall Compliance: No		Severity Score: 12.5							
Codes/Mitigation Info/Possible Solution				Field Measurements/Component Compliance

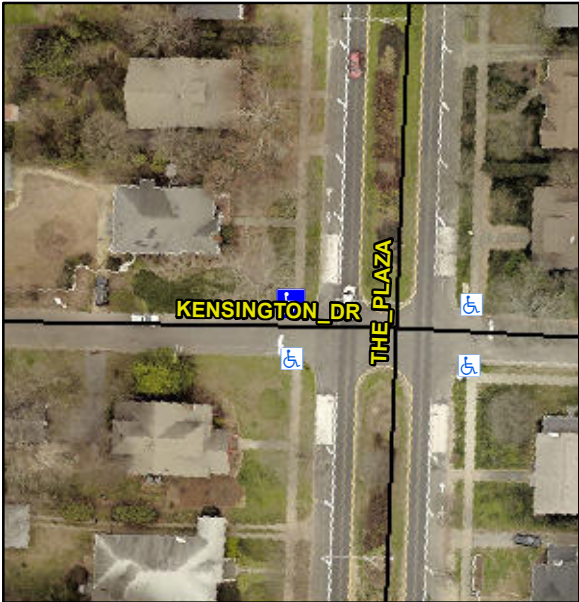
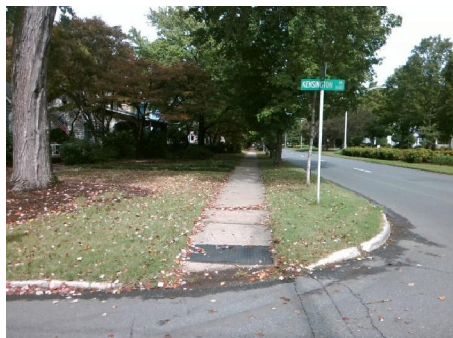
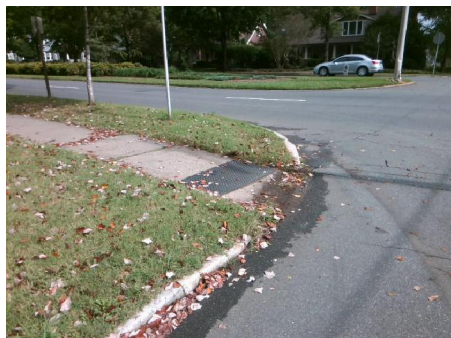
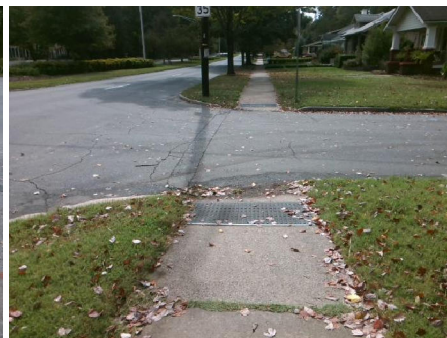
Possible Solutions:		Compliance		Description		Data		Compliance		Description		Data	
		Remove & Replace Entire Ramp.		N/A		Ramp Length (in)		84.0		No		Ramp Slope (%)		9.0	
				Yes		Ramp Width (in)		56.0		Yes		Ramp XSlope (%)		1.8	
				N/A		Flare Type LT		N/A		N/A		Flare Type RT		N/A	
				N/A		Flare Slope LT (%)		N/A		N/A		Flare Slope RT (%)		N/A	
				N/A		Flare Traversable LT?		N/A		N/A		Flare Traversable RT?		N/A	
				N/A		Landing Length (in)		N/A		N/A		DWS Provided?		N/A	
				N/A		Landing Width (in)		N/A		N/A		DWS Contrast?		N/A	
				N/A		Landing Slope (%)		N/A		N/A		DWS Length (in)		N/A	
				N/A		Landing X Slope (%)		N/A		N/A		DWS Full Width?		N/A

<div>Surveyor Notes:</div> <div>N/A</div> <div>PROW/ADA:</div> <div>R304.2.2</div>		N/A		N/A		Landing Curb? (Y/N)		N/A		N/A		DWS Offset (in)		N/A	
				N/A		Shared Landing?		N/A							
				N/A		Gutter Ponding?		Yes		N/A		Gutter Slope (%)		N/A	
				N/A		Gutter Lip Ht (in)		N/A		N/A		Gutter X Slope (%)		N/A	
				N/A		Painted X Walk1?		No		N/A		Painted X Walk2?		N/A	
						X Walk 1 Direction		To S				X Walk 2 Direction		N/A	
				N/A		X Walk 1 Width (in)		N/A		N/A		X Walk 2 Width (in)		N/A	
						X Walk 1 Slope (%)		2.2				X Walk 2 Slope (%)		N/A	
						X Walk 1 X Slope (%)		2.1				X Walk 2 X Slope (%)		N/A	
				N/A		Ramp inside XWalk1?		N/A		N/A		Ramp inside XWalk2?		N/A	
<div>Total Cost:</div> <div>\$ 1850.00</div>						Road Slope (%)		N/A		N/A		Clear Space?		N/A	
						Road X Slope (%)		N/A		N/A		Clear Space to XWalk (in)		N/A	
				N/A		Any Obstructions?		N/A		N/A		Storm Grate/Utility Hazard?		N/A	
						Obstruction Type						Storm Grate/Utility Type

N/A						N/A	
								Yes		Surface Condition? (G/P)		Good
