# Access Compliance Report

## Public Rights-of-Way

### (Curb Ramps)

Intersection ID: 30613	Main Street: GOLF_LINKS_DR	Cross Street: PROVIDENCE_RD	Location: SW
ADA ID: 072B7E612924	Ramp Type: Perp	Initial Pass/Fail: Fail	Overall Compliance: No
			Severity Score: 13.75

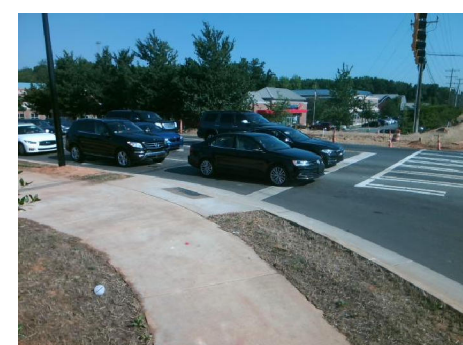
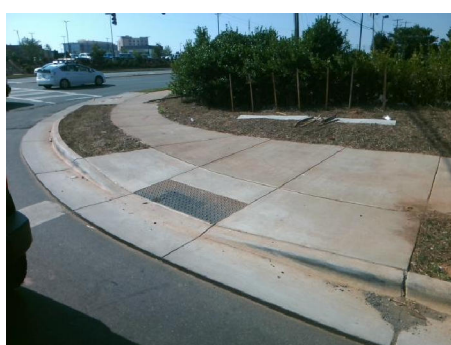
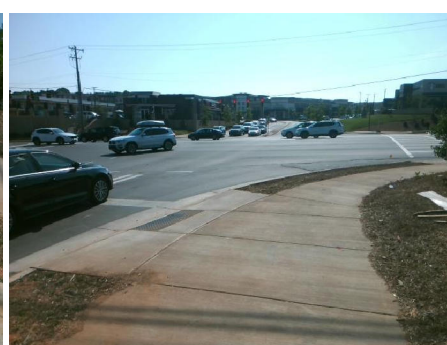
**Not Found, R304.2.2, R304.5.3**

Compliance	Description	Data	Compliance	Description	Data
N/A	Ramp Length (in)	46.0	No	Ramp Slope (%)	9.8
Yes	Ramp Width (in)	59.0	No	Ramp XSlope (%)	3.2
N/A	Flare Type LT	N/A	N/A	Flare Type RT	N/A
N/A	Flare Slope LT (%)	N/A	N/A	Flare Slope RT (%)	N/A
N/A	Flare Traversable LT?	N/A	N/A	Flare Traversable RT?	N/A
N/A	Landing Length (in)	N/A	N/A	DWS Provided?	N/A
N/A	Landing Width (in)	N/A	N/A	DWS Contrast?	N/A
N/A	Landing Slope (%)	N/A	N/A	DWS Length (in)	N/A
N/A	Landing X Slope (%)	N/A	N/A	DWS Full Width?	N/A
N/A	Landing Curb? (Y/N)	N/A	N/A	DWS Offset (in)	N/A
N/A	Shared Landing?	N/A			
N/A	Gutter Ponding?	N/A	N/A	Gutter Slope (%)	N/A
N/A	Gutter Lip Ht (in)	2.0	N/A	Gutter X Slope (%)	N/A
N/A	Painted X Walk1?	No	N/A	Painted X Walk2?	N/A
	X Walk 1 Direction	To N		X Walk 2 Direction	N/A
N/A	X Walk 1 Width (in)	N/A	N/A	X Walk 2 Width (in)	N/A
	X Walk 1 Slope (%)	0.8		X Walk 2 Slope (%)	N/A
	X Walk 1 X Slope (%)	2.6		X Walk 2 X Slope (%)	N/A

N/A	Ramp inside XWalk1?	N/A	N/A	Ramp inside XWalk2?	N/A
	Road Slope (%)	N/A	N/A	Clear Space?	N/A
	Road X Slope (%)	N/A	N/A	Clear Space to XWalk (in)	N/A
N/A	Any Obstructions?	N/A	N/A	Storm Grate/Utility Hazard?	N/A
	Obstruction Type			Storm Grate/Utility Type	
		N/A			N/A
			Yes	Surface Condition? (G/P)	Good

**Remove & Replace Entire Ramp.**
